Moore Trees  
Arboricultural Services

# Arboricultural Development Assessment Report

Lilyfield Skate Plaza  
Leichhardt Park  
70 Mary Street  
Lilyfield NSW 2040  
February 2022  
*Final*

Prepared for: Inner West Council

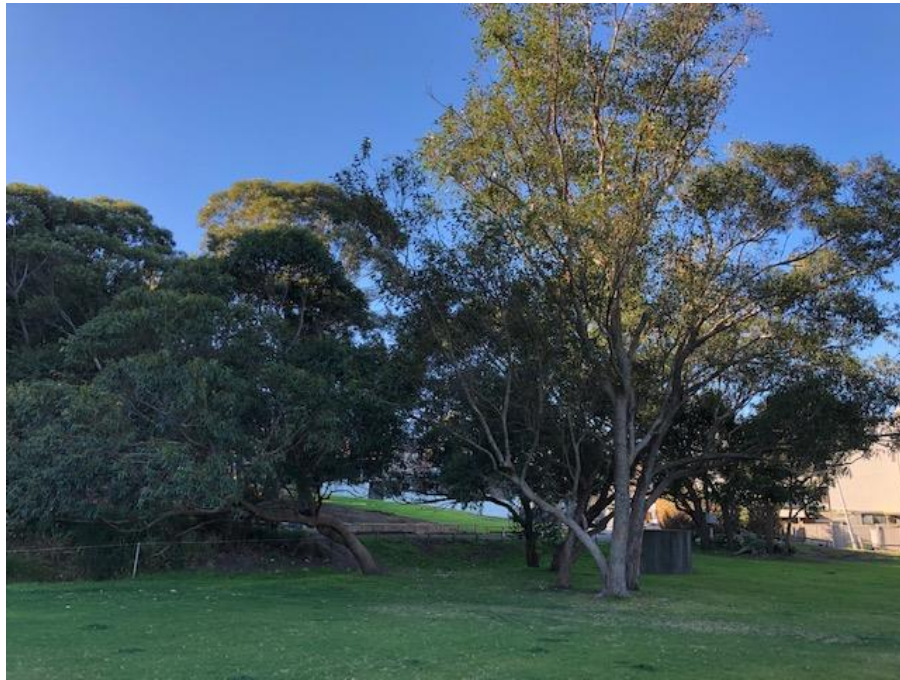
**Plate 1:** Image showing Trees 1, 3-8. P. Vezgoff

- 3.7** Trees 1, 3, 4, 5, 6, 7, and 8 are growing as a group and share codominant canopies with each other. Most have asymmetrical canopy development due to their proximity of growing to each other (Plate 1). Tree 1 has an extreme canopy bias of ten (10) metres, which appears to have developed possibly due to growing next to a larger tree that is no longer present. Tree 1 has branching development problems by way of large branches that are rubbing and single leader that is trying to self-correct, causing it to clash with another lateral branch.

- 3.8** Tree 4 has a large wound on the south-eastern side of the stem, and it appears lignified however there is evidence of Longicorn beetle damage and wound wood development is occurring, but this is also being attacked by borers. Trees 5, 6, 7 and 8 appear to have suffered ring bark damage around the basal area at some stage as evidenced by the wounding that has occurred and created extensive wounds around the circumference of the base of each one of these trees (Plate 2). It is difficult to determine the extent of damage, however it appears to be more than 5 years old and the canopies do not show evidence of cambial damage such as major dieback and poor foliage vigour.

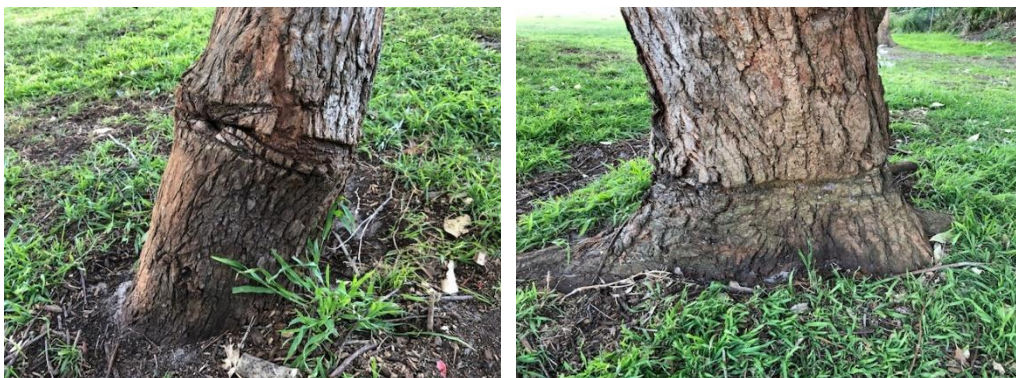
- 3.5 Illegal tree removal:** It was noted that several of the site trees have been attempted to be ring barked, most likely for harbour views. These trees are numbered as 6, 7 and 8. Also of note, within the same sight line from Frazer Street, are dead and dying trees within Tree group 9-13. Residents should be informed that damaging or removing public trees can result in heavy fines. Local Government does have the authority to issue on the spot fines known as penalty infringement notices (PINS) starting from \$3,000 or can elect to have a potential tree damaging incident addressed in the Local Court. Recent cases, for example, include two (2) mature trees removed for development (Sutherland Shire Council (SSC) v Palamara, 2008) costing \$4,500 in fines and \$5,000 in court costs. SSC v El-Hage, 2010 concerning illegal tree removal of a single tree costing \$31,500 in fines and \$5,000 in costs. Poisoning trees can also incur substantial fines (SSC v Hill) resulted in a single tree fine that totalled \$14,000 plus a \$10,000 bond for a replacement tree. All of the above cases resulted in a criminal conviction for the guilty parties.

**Plate 2:** Image showing old ringbarking damage. P. Vezgoff

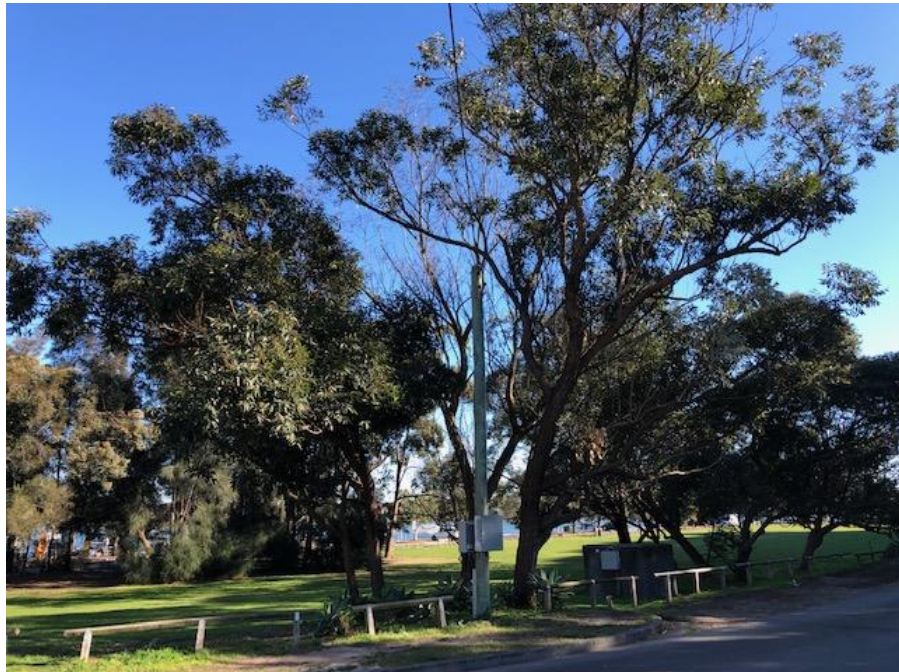
**Plate 3:** Image showing Trees 9-13. P. Vezgoff

**3.10** Trees 9-13 are located in the south-west corner and Tree 11 is no longer present, it is a stump which has been partially removed from the ground. Tree 10 is dead and appears to have died fairly recently, however there is no evidence of any poisoning or vandalism at the base of this tree (Plate 3). There is a power pole within three (3) metres of the base of the tree that has meter boxes attached to either side of it and it is possible roots may have been severed with any works from these meter boxes, that may have affected this tree. Trees 12 and 13 are reasonably suppressed specimens with limbs growing against each other, due to their proximity to each other.

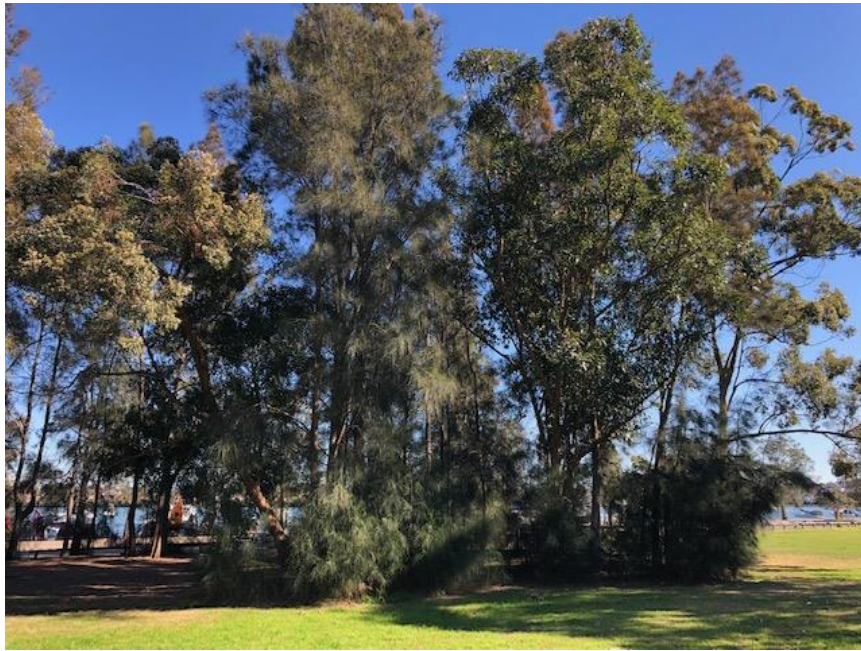
**Plate 4:** Image showing Trees 17-26. P. Vezgoff

**3.11** Trees 17-26 form a dense group of vegetation with much suckering occurring from the Casuarinas which is quite normal for this species (Plate 4). Within this group is a Swamp Mahogany (*Eucalyptus robusta*), being Tree 19, and it is potentially not a long term viable specimen. This tree is possibly beginning to develop included stems.

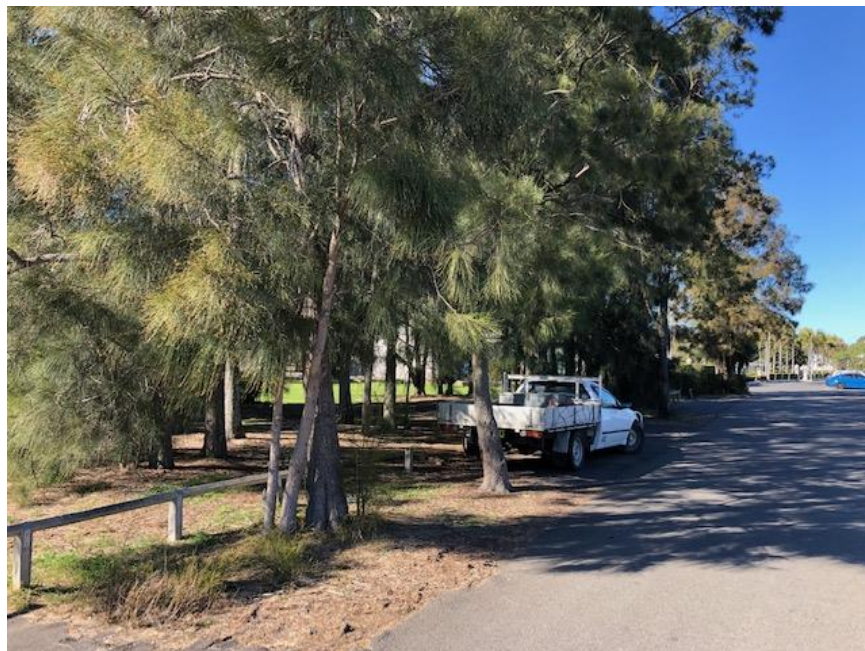
**Plate 5:** Image showing Trees 27-29. P. Vezgoff

**3.12** Trees 27-29 are growing along the road (Plate 5). They have asphalt virtually up to the base of these trees. There is extensive woody root growth occurring with some disruption to the asphalt forming. Considering their location, and the harsh conditions in which they are growing, these trees are in reasonable condition. It is unlikely that they would tolerate any resurfacing works that might occur around the base of them. As individual specimens they would not be considered significant.

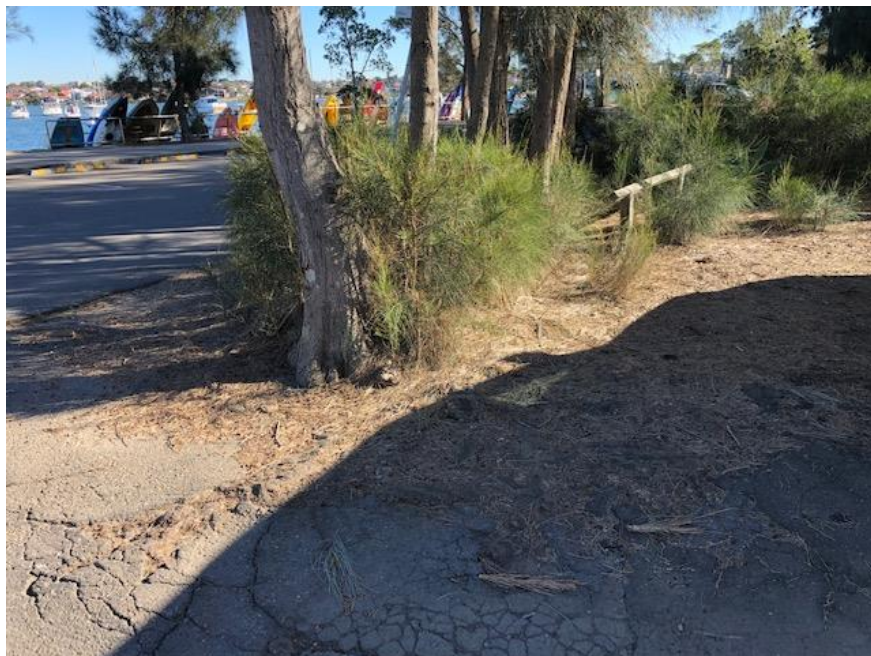
**Plate 6:** Image showing the base of Trees 42-49. P. Vezgoff

- 3.16** Trees 42-49 are a group of Casuarinas in good health and condition, all growing as a clump, with a lot of exposed woody roots with this group of trees. They are growing on the corner of the site and disrupting the asphalt quite substantially (Plate 6). There is much suckering occurring at the base of these trees which is quite normal for the species.
