DEVELOPMENT OF RECOMMENDATIONS

ANALYSIS AND RECOMMENDATIONS

22 August 2018

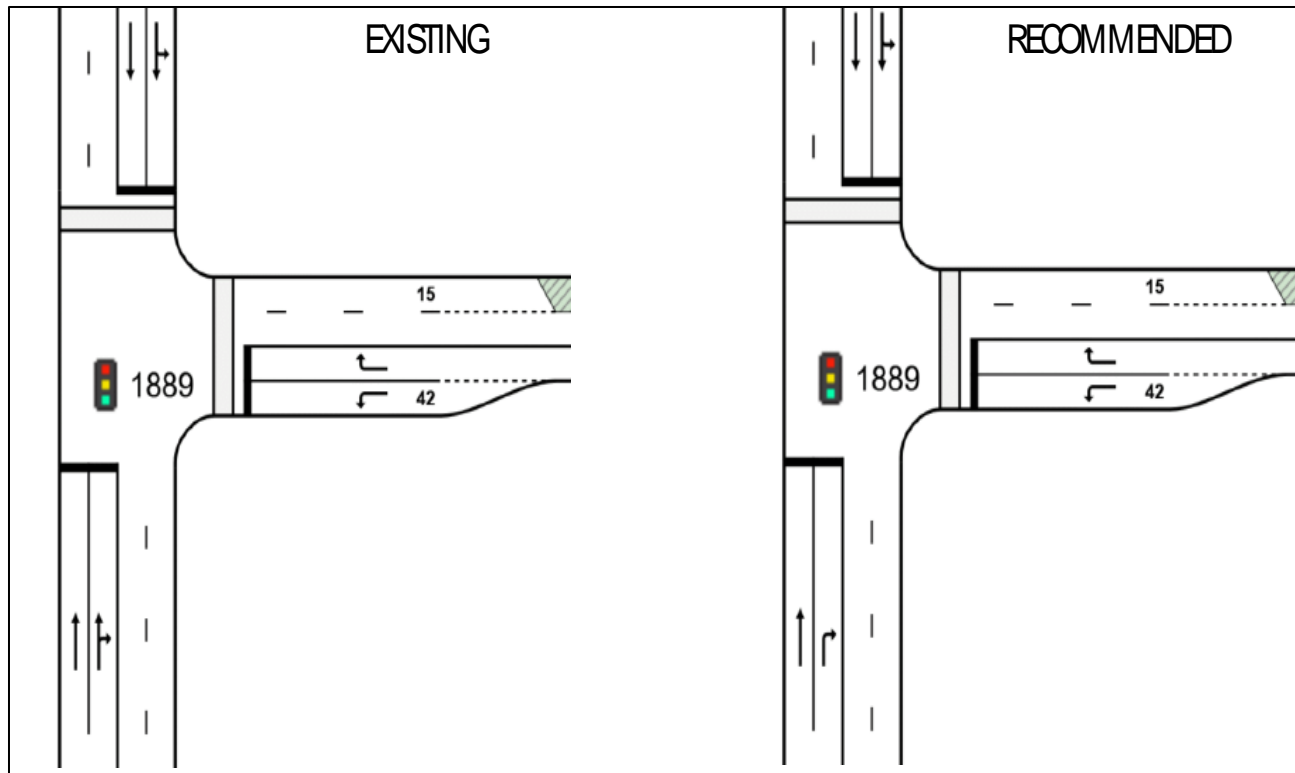
ENMORE ROAD / LLEWELYN STREET INTERSECTION SOLUTION

ENMORE ROAD / LLEWELYN STREET INTERSECTION PROBLEM

This intersection has 7 crashes.

- Crash type “right through” occurred 3 times in this intersection.
- Occurs when a vehicle turning right (from Enmore Road into Llewellyn St) collides with an opposing vehicle traveling straight through the intersection.
- Vehicles turning right have to “filter” through the opposing straight movement (that is there is no green arrow phase to protect the right hand turn).

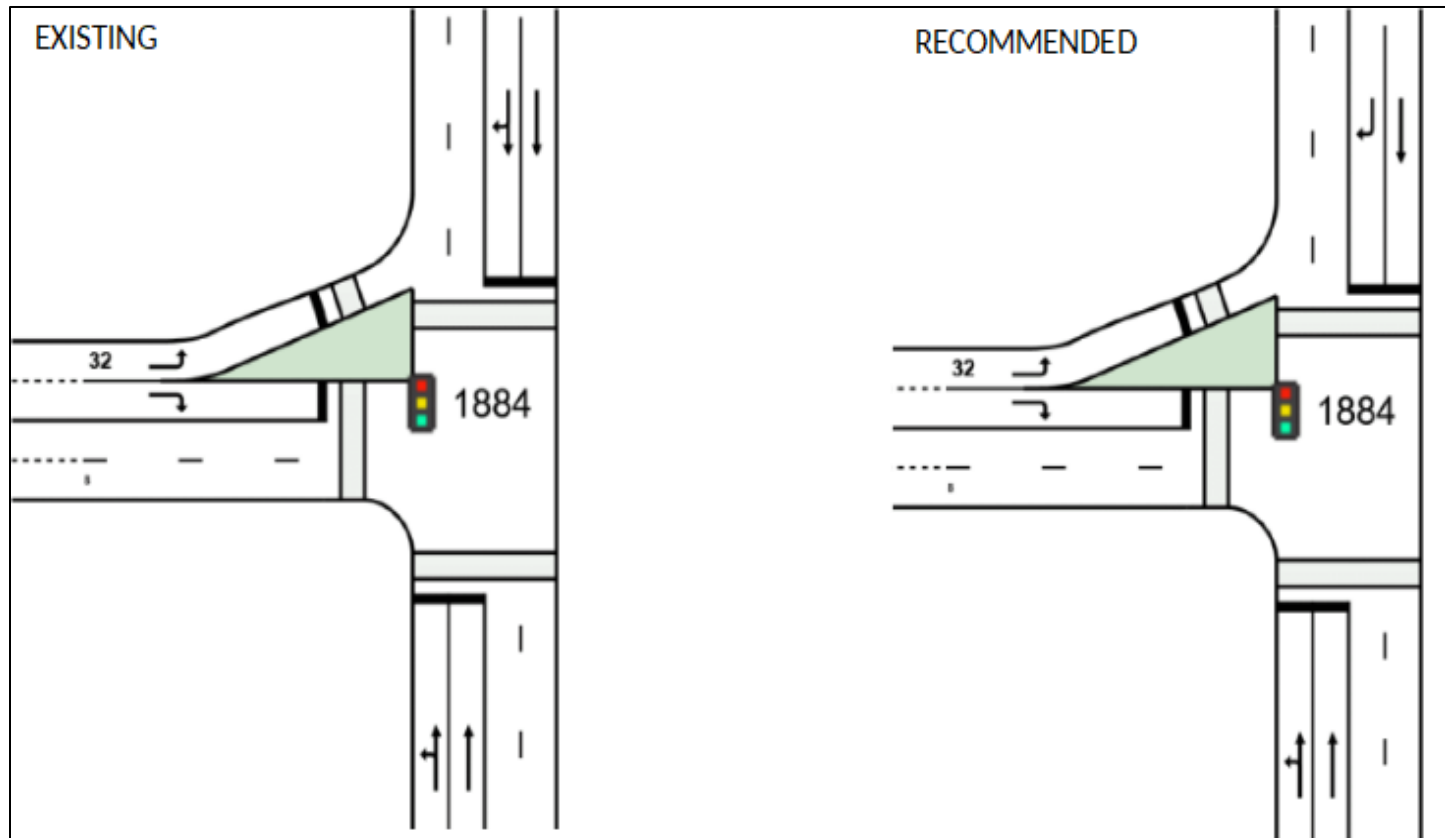
ENMORE ROAD/ ADDISON ROAD INTERSECTION SOLUTION

ENMORE ROAD/ ADDISON ROAD INTERSECTION PROBLEM

This intersection has five crashes.

- Crash type “right through” occurred 3 times in this intersection, of the 4 crashes involving a turning movement.
- Vehicles turning right have to “filter” through the opposing straight movement (that is there is no green arrow phase to protection the right hand turn).
- The intersection currently operates at a lower level of service in the morning - longer delays occur on the northern approach to the intersection (Enmore Road).
- Drivers choose inappropriate gaps for their right hand turns due to longer waiting times).

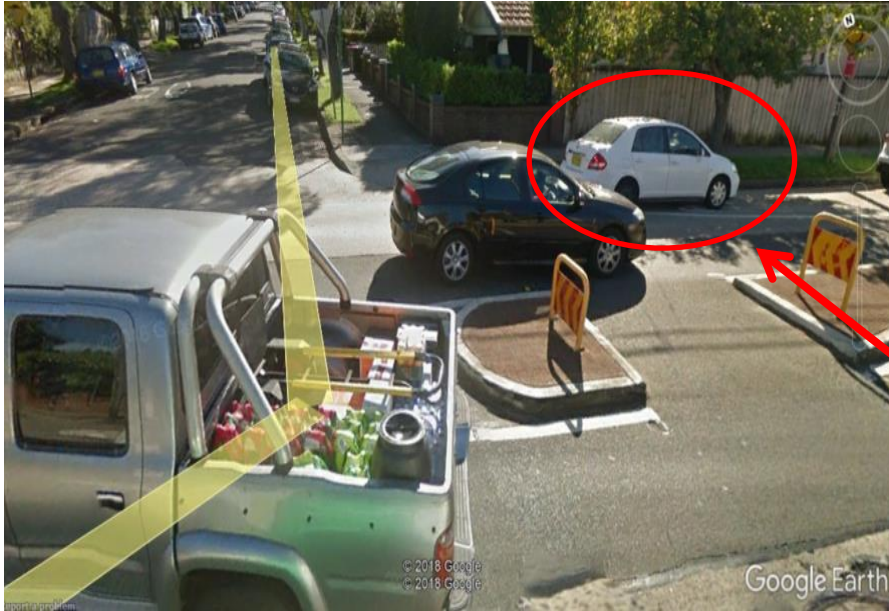
PROBLEM EXAMPLE: ADDISON ROAD AT AUDLEY STREET – SCHOOL CROSSING AREA

The existing situation has one ramp unaligned at the intersection of Audley Street channelling pedestrians into the intersection instead of servicing the footpath for crossing Audley Street, and another aligned with the gap in the refuge island.

Cars can park in the area where pedestrians need to cross, creating an unsafe situation particularly for children and elderly.

This is a crossing facility for school children.

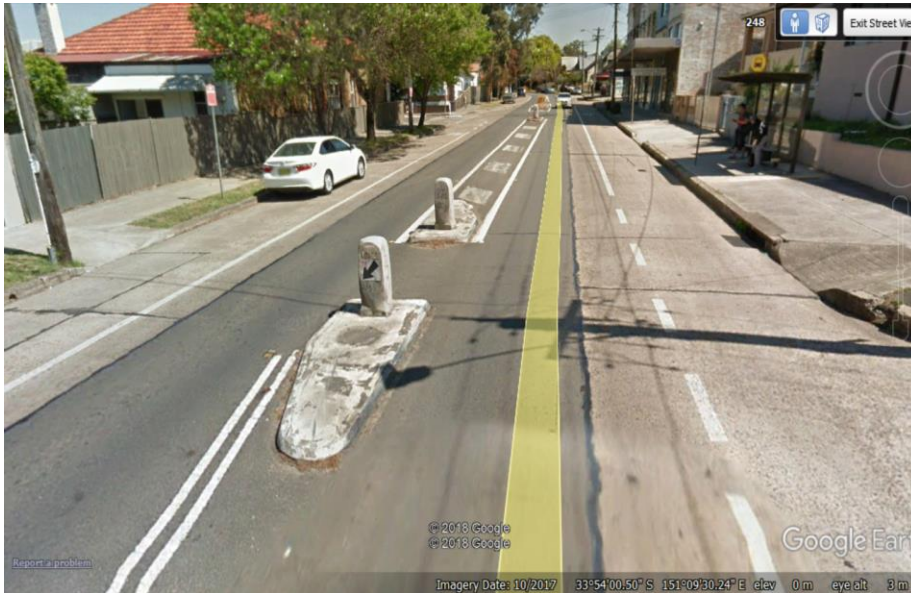
PROBLEM: ADDISON ROAD OUTDATED INFRASTRUCTURE

This type of pedestrian refuge is no longer the standard in NSW. However should an updated version be installed it would have to comply with parking set-backs which may cause inconvenience to residents.

These refuges have no kerb extensions and rely on visibility maintenance to remain effective
