## CONSERVATION MANAGEMENT PLAN

CARETAKER'S COTTAGE  
ELKINGTON PARK  
BALMAIN NSW 2041

4 November 2015  
FINAL

NBRS & PARTNERS Pty Ltd  
Level 3, 4 Glen Street  
Milsons Point  
NSW 2061 Australia

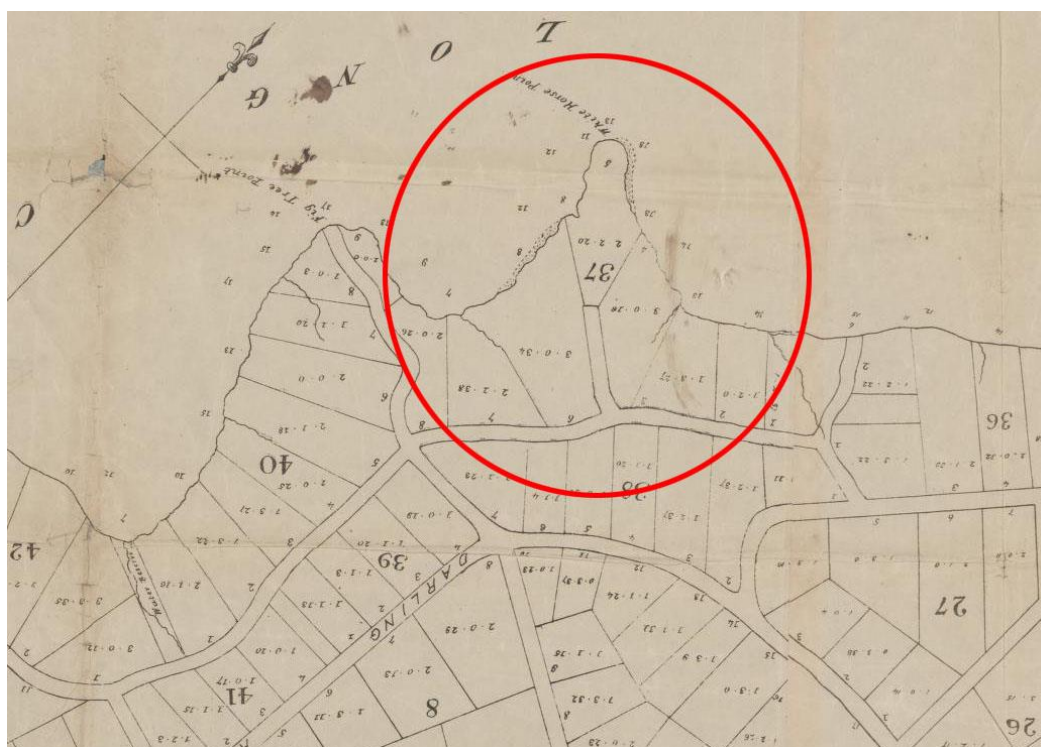
Figure 2 — Extract from Charles E Langley / Plan of Balmain Estate, 1852. Section 37 circled thereon. (Source: NLA, MAP F 535)

Elkington Park is located on part of Lot 37 of the Balmain Estate, subdivided in 1852 as shown in the plan of survey by Charles Langley (Figure 2). The Trustees of the Gilchrist Estate conveyed Lots 1, 2, 3 and 4 of Section 37 of the Balmain Estate on 11 March 1861 to Ewen Wallace Cameron of Balmain.<sup>2</sup> In separate transactions, Cameron also acquired Lots 1, 2, 3 and part of 4 of Section 36.<sup>3</sup>

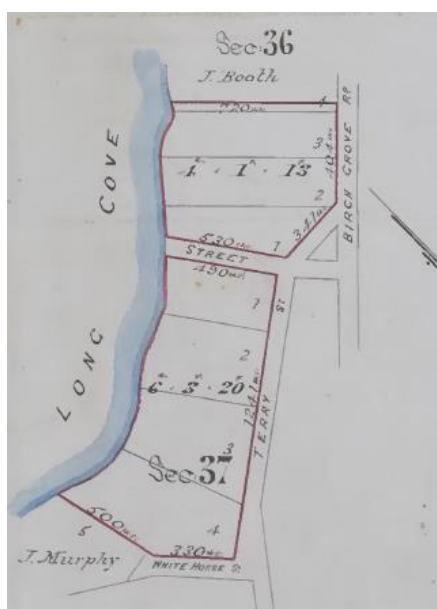
Figure 3 — Block plan of land accompanying Certificate of Title Vol 262 Fol 233, registered in the name of Ewen Wallace Cameron, 9 August 1876. (Source: NSW Land & Property Information)

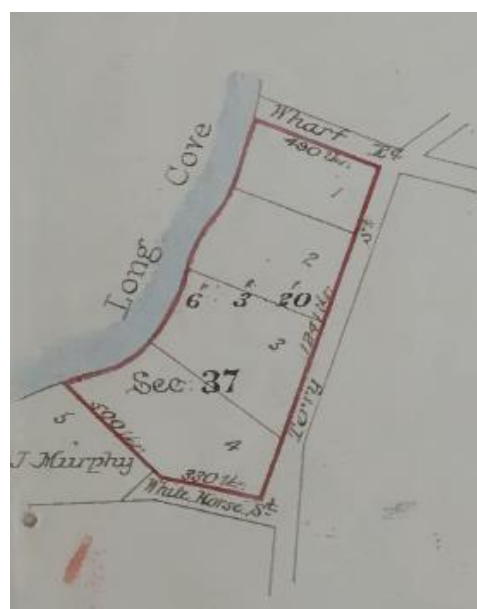
Figure 4 — Block plan of land accompanying Certificate of Title Vol 485 Fol 87, registered in the name of Theodore James Jaques, 19 February 1880. (Source: NSW Land & Property Information)

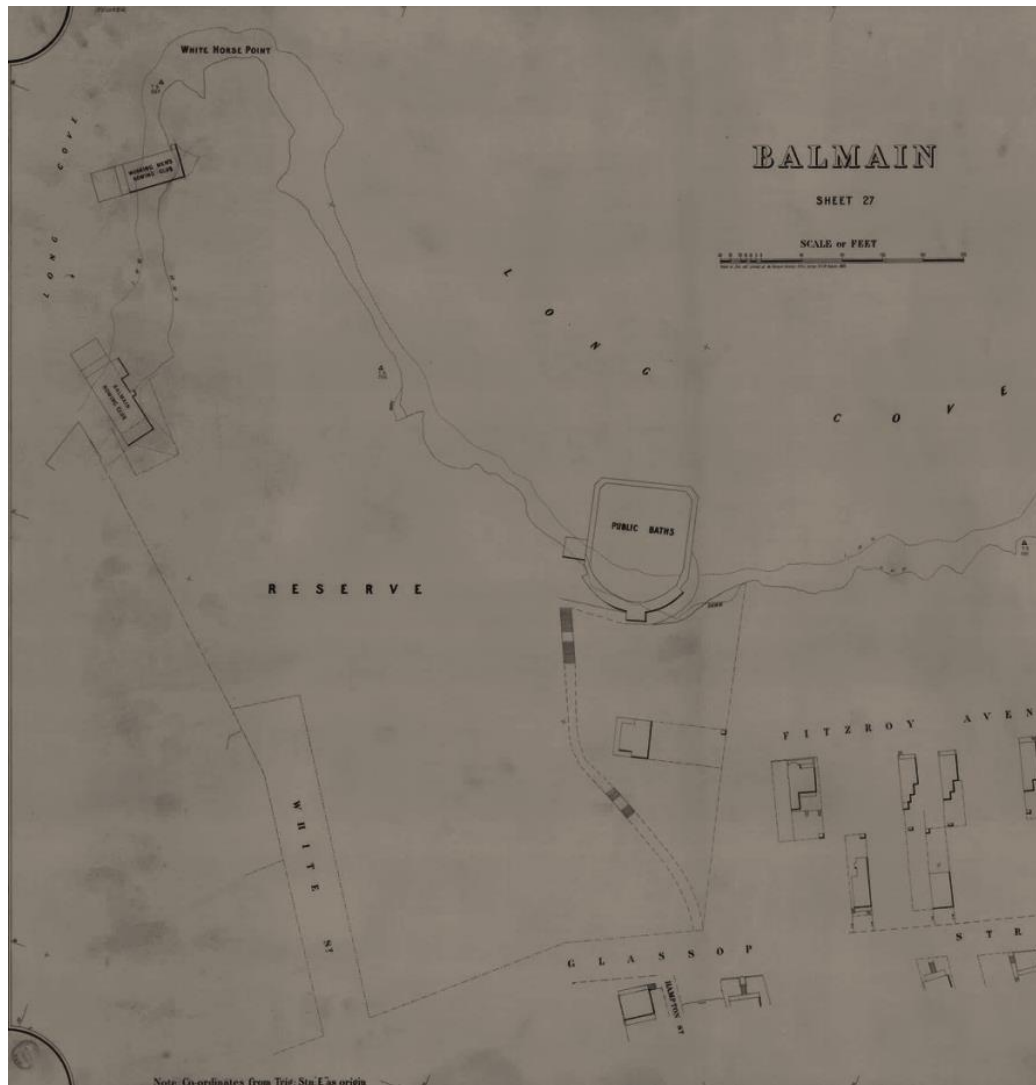
Figure 11 — Detail Survey Balmain Sheet 27, 1888. (Source: State Library of New South Wales, Digital Order No a1367044)

In the detail survey of the locality dated April 1888 (Figure 11), the area then encompassing the “White Horse Point Reserve” is shown with Public Baths and cottage located in the crook of Long Cove. A path and steps is shown extending from the south eastern corner of the site on Glassop Street, past the cottage to the Baths. The cottage occupies its own site with fenced yard. The cottage is located in the reserve adjacent to the western end of Fitzroy Avenue. The Working Men’s Rowing Club and Balmain Rowing Club are shown on the western side of White Horse Point fronting Long Cove.

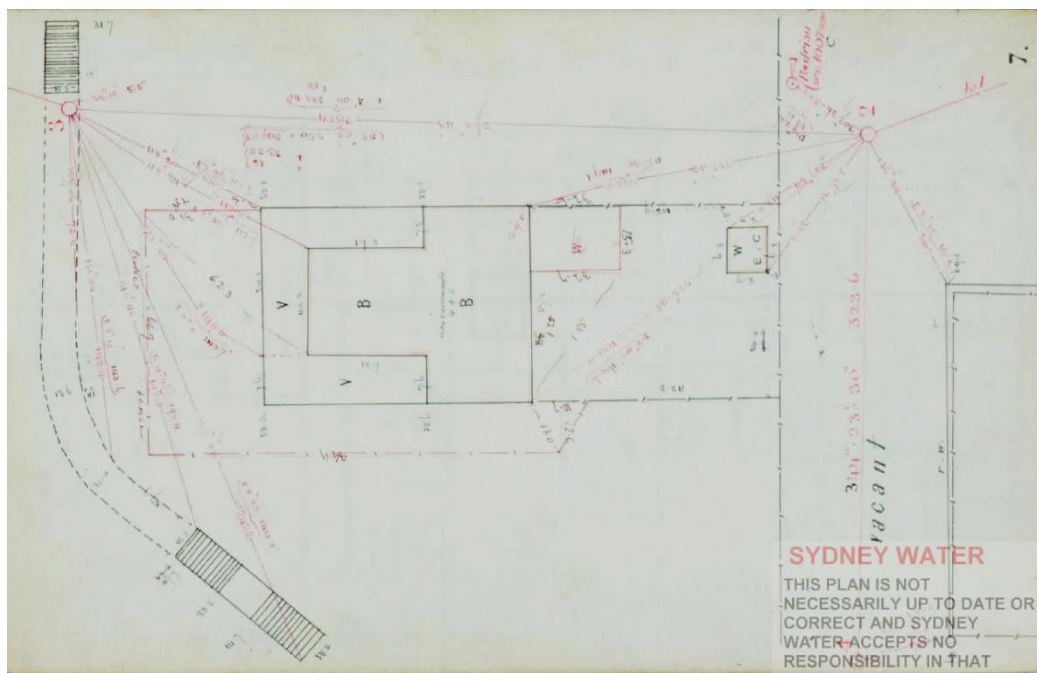
Figure 20 — Survey of subject building on page 7 of Field Book No 1376 Sheets 27 & 38 Balmain, April 1888 / Surveyor A Peake. (Source: Sydney Water Historical Archives)

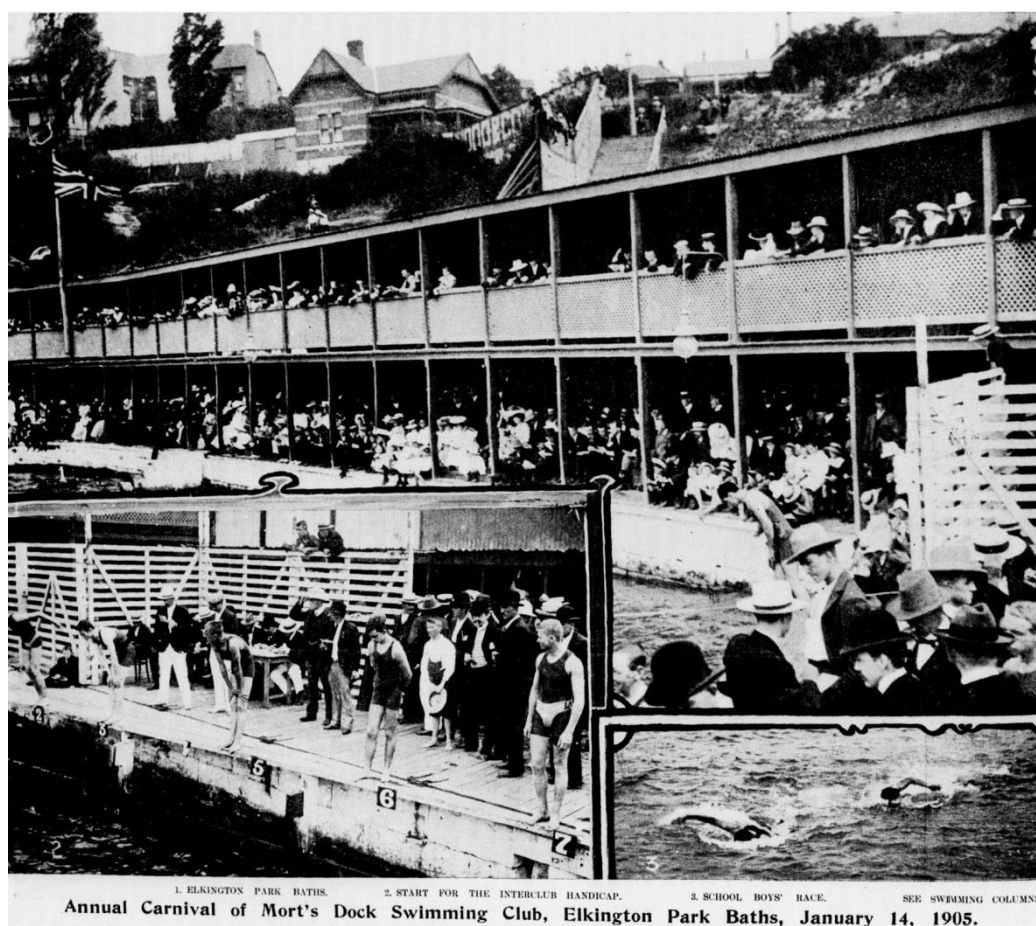
Figure 22 — Annual carnival at Mort's Dock Swimming Club, Elkington Baths, January 14, 1905 - showing the Caretaker's Cottage in the background (Source: Sydney Mail, 18 January 1905, p158)

Photographic evidence should be used to reconstruct any original elements. Figure 15, Figure 22 and Figure 23 show the decorative timber gable screen and finial on all gables of the Caretaker's Cottage. The decorative gable element and finial is missing from the gable on the west elevation of the Caretaker's Cottage. This should be reconstructed as part of any conservation works to the building.

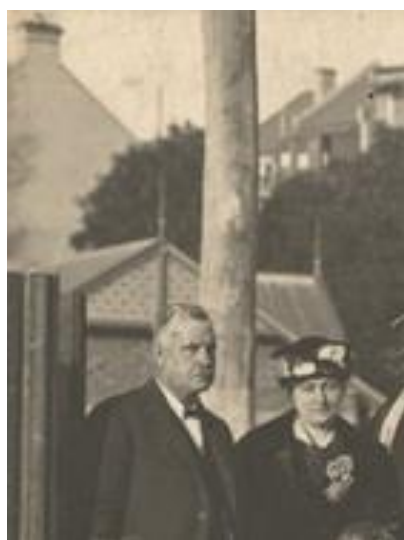
Figure 23 — Enlargement of photograph shown at Figure 15 showing portion of Caretaker's Cottage in background. (Source: Australian War Memorial, ID number P10419.002)

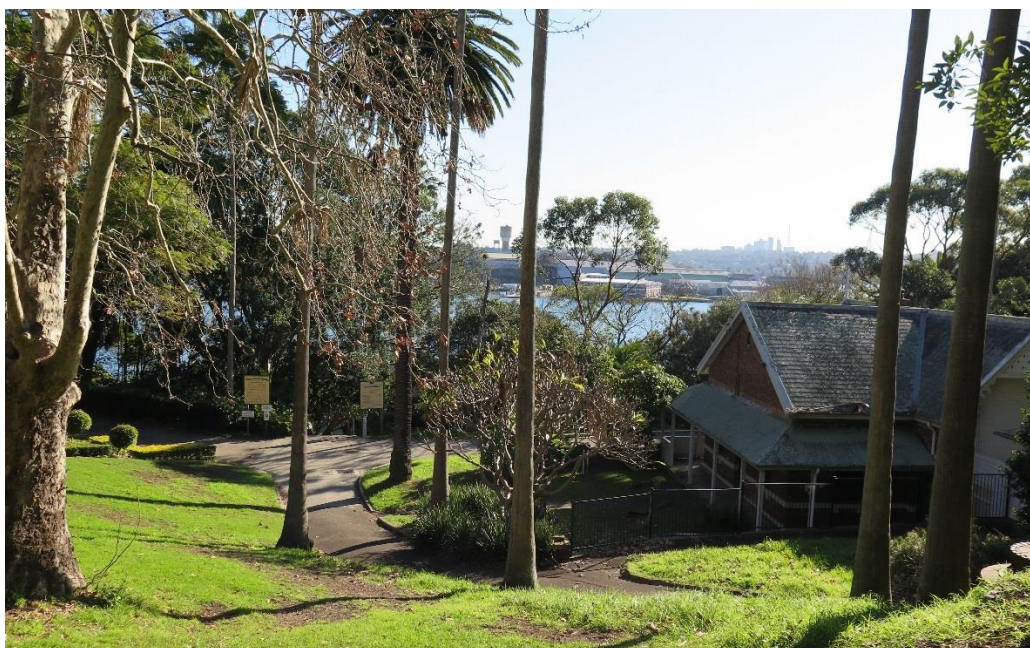
*Figure 31 — View north from Elkington Park showing the Caretaker's Cottage sunken within the parklands and surrounded by mature palm trees (Source: NBRS+PARTNERS, July 2015)*

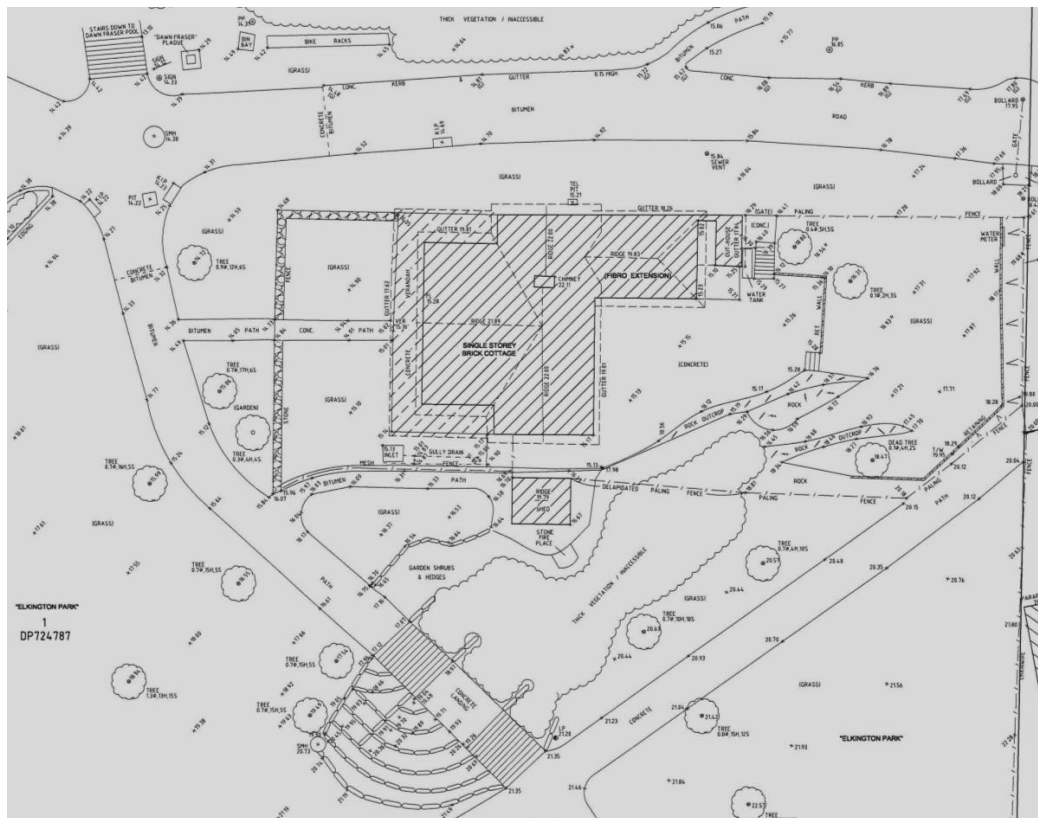
Figure 33 — Plan Showing Selected Detail and Levels Over Elkington Park Cottage, Balmain (Source: Norton Survey Partners, Date 2 February 2015)

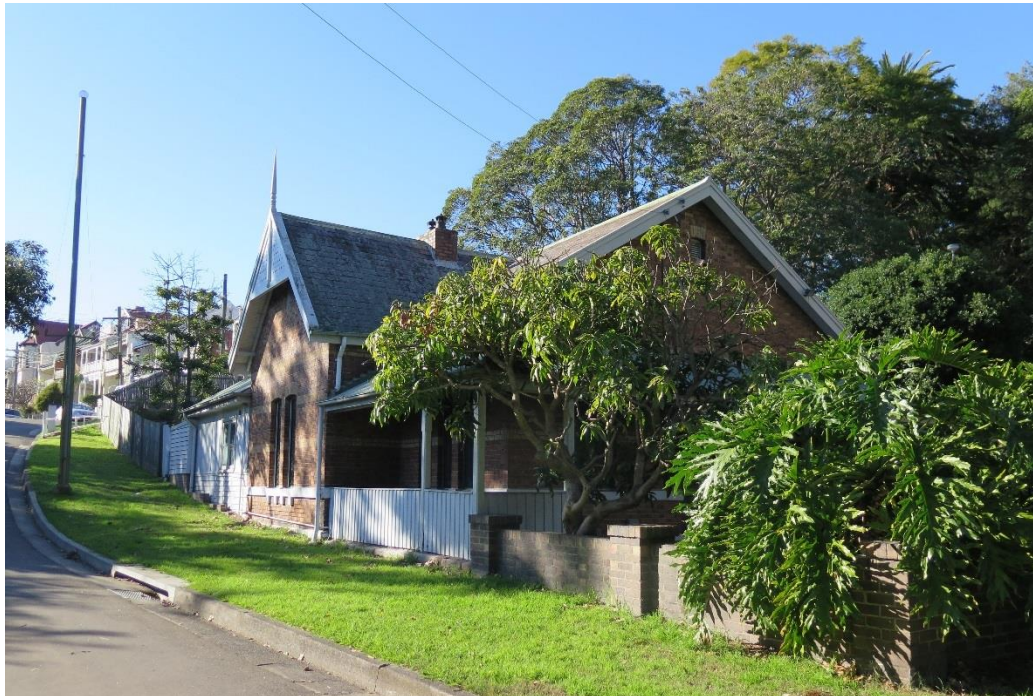
*Figure 34 — View east from Elkington Park to Caretaker's Cottage with Fitzroy Avenue located in the background (Source: NBRS+PARTNERS, July 2015)*

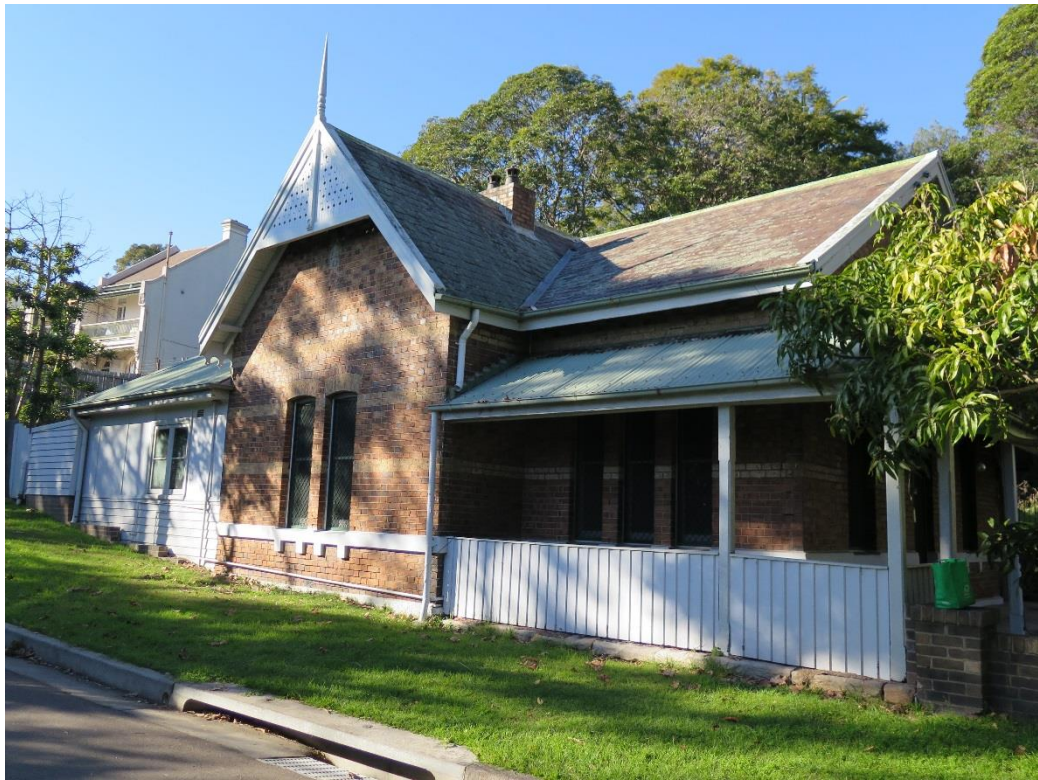
*Figure 35 — North Elevation of the Caretaker's Cottage showing polychromatic brickwork and slate roof with corrugated metal roof to the verandah (Source: NBRS+PARTNERS, July 2015)*

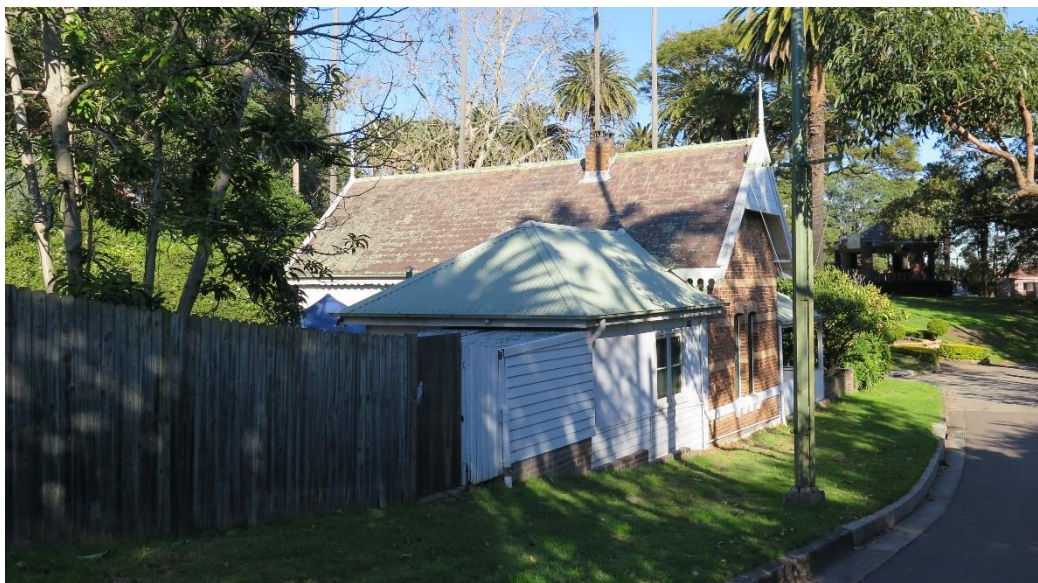
*Figure 36 — North and East Elevations of the Caretaker's Cottage looking west towards Elkington Park. A timber panel addition with hipped corrugated metal roof contains the laundry, kitchen and bathroom adjoins the East Elevation of the cottage (Source: NBRS+PARTNERS, July 2015)*

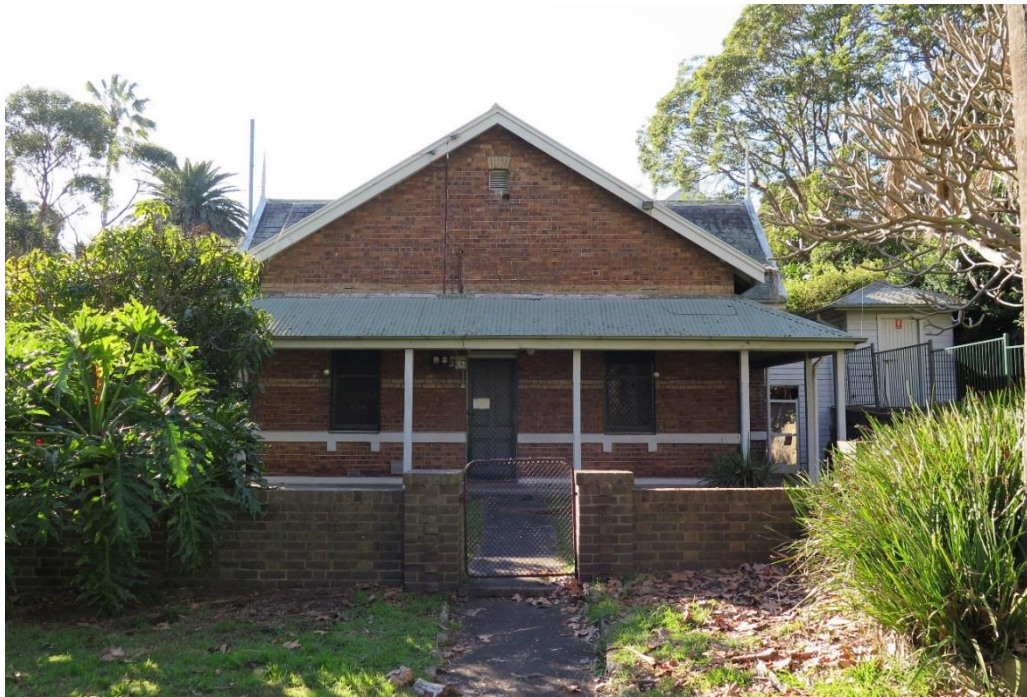
*Figure 37 — West Elevation of the Caretaker's Cottage, facing Elkington Park, is symmetrically designed, and contains the principal cottage entry (Source: NBRS+PARTNERS, July 2015)*

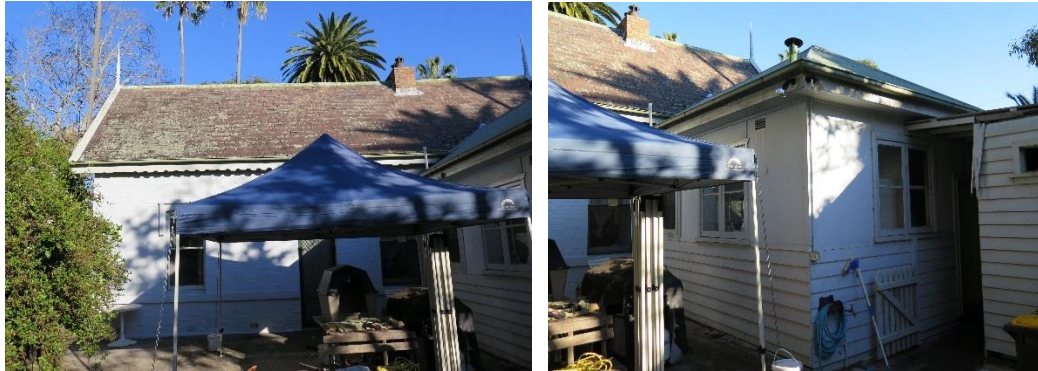
*Figure 39 — Caretaker's Cottage, East Elevation showing the timber-clad utilities addition at right. (Source: NBRSPARTNERS, July 2015)*

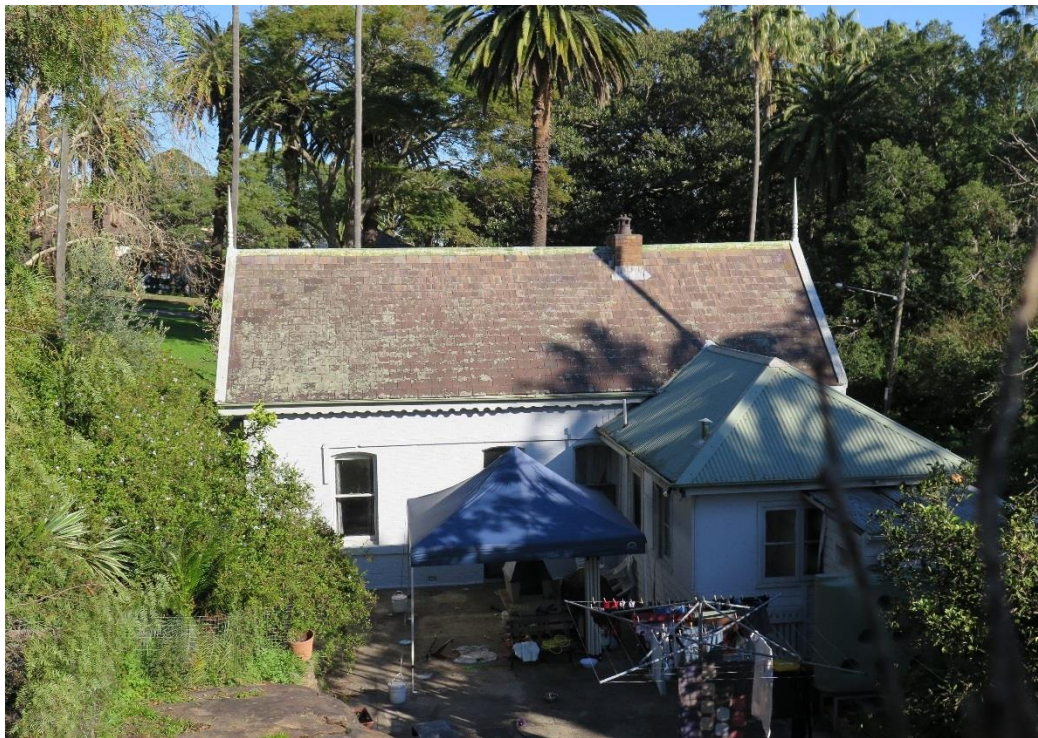
*Figure 40 — Caretaker's Cottage, East Elevation with Elkington Park in the background. The utilities addition is shown at right and abuts the slate roof. The facebrick walls of the original cottage has been painted. The rear yard is concrete paved with rock boulders located in the eastern corner of the property. (Source: NBRSPARTNERS, July 2015)*

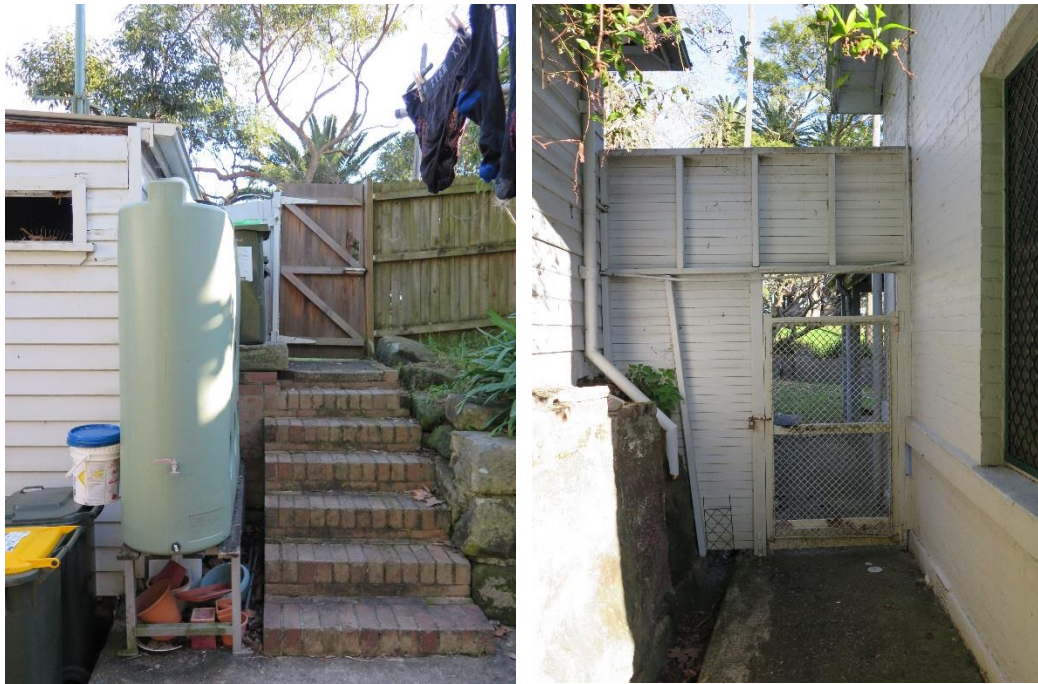
*Figure 41 — Caretaker's Cottage, brick steps lead from the rear yard to the Fitzroy Avenue service road (left). Timber wall and gate prevent access to the rear of the property (Source: NBRSPARTNERS, July 2015)*

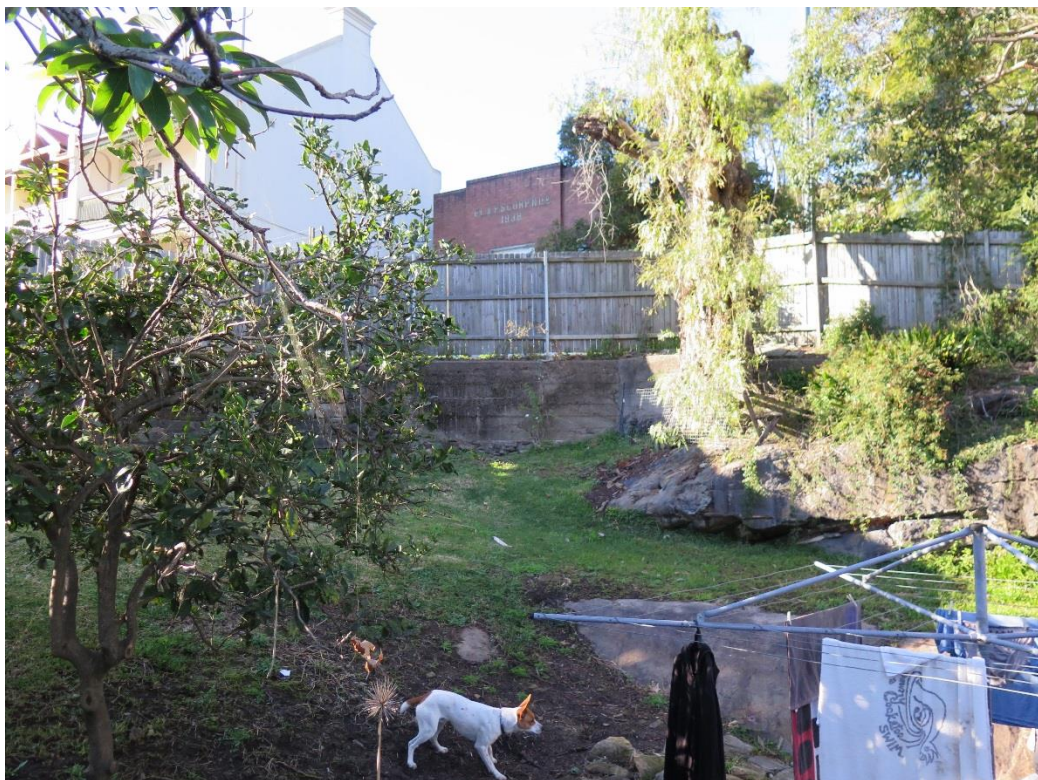
*Figure 42 — Caretaker's Cottage, looking east to the rock outcrop in the rear yard, concrete retaining wall with timber paling fence on the property boundary (Source: NBRSPARTNERS, July 2015)*

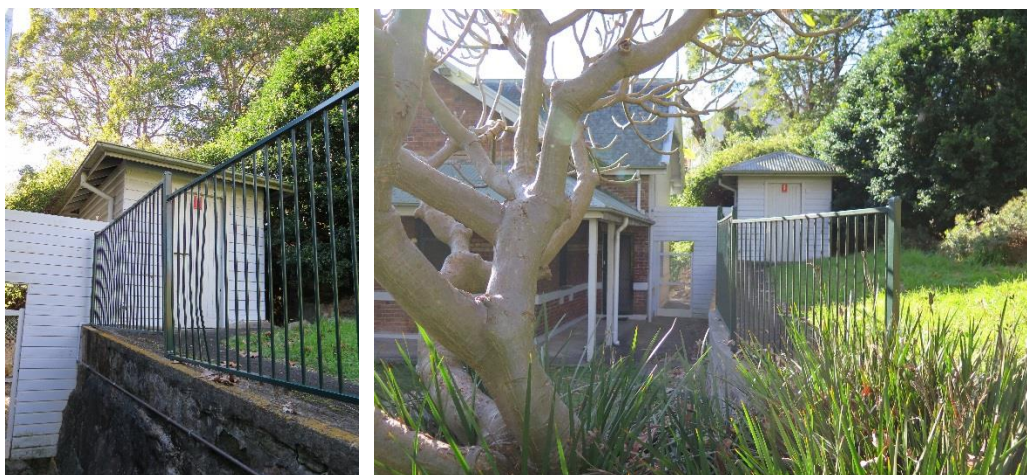
Figure 43 — Caretaker's Cottage, looking east from the park to Council garden shed on a raised section, south of the property. A timber partition wall and gate prevent access to the rear of the property. The side door to the hall of the cottage is located at the end of the verandah (Source: NBRSPARTNERS, July 2015)

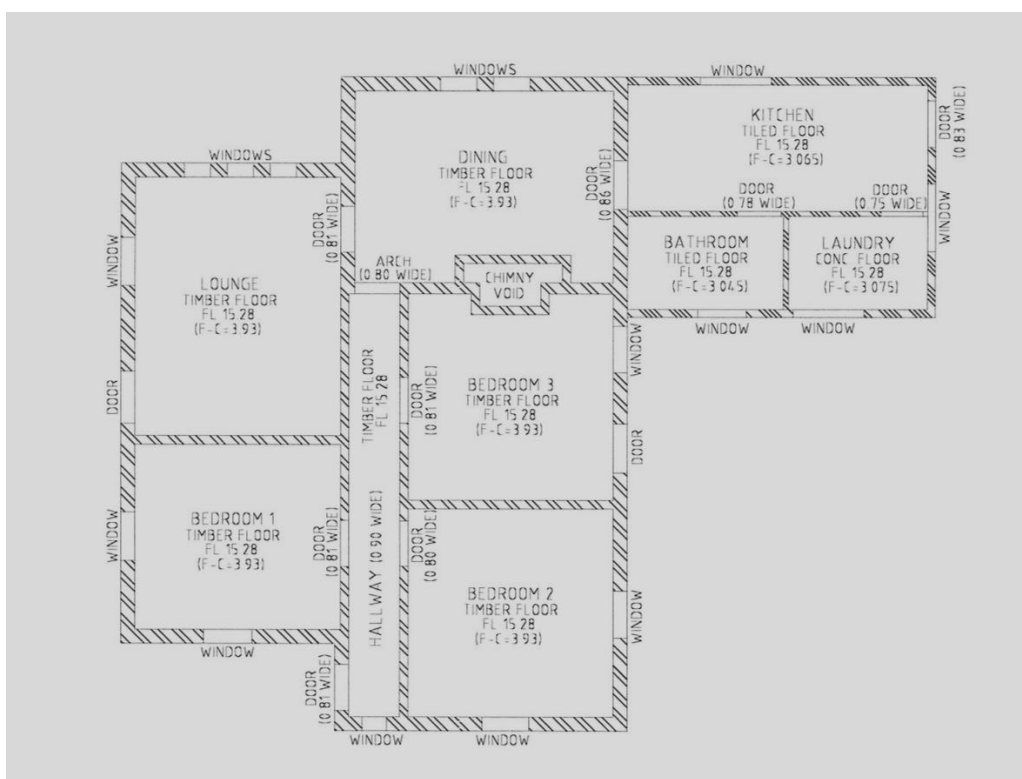
Figure 44 — Plan Showing Internal Layout of Elkington Park Cottage, Balmain (Source: Norton Survey Partners, 3 February, 2015)

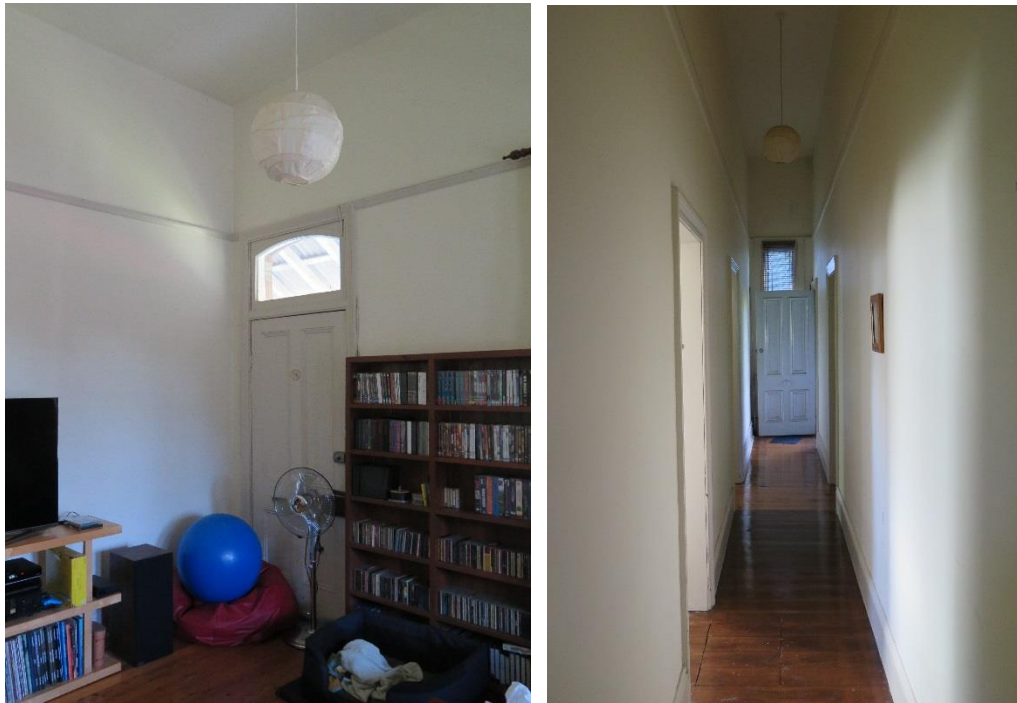
*Figure 45 — Caretaker's Cottage, showing the living room with front door and fanlight over (left). The hall (900mm wide) connects with the side door and provides access to all rooms in the cottage, except lounge room (Source: NBRSPARTNERS, July 2015)*

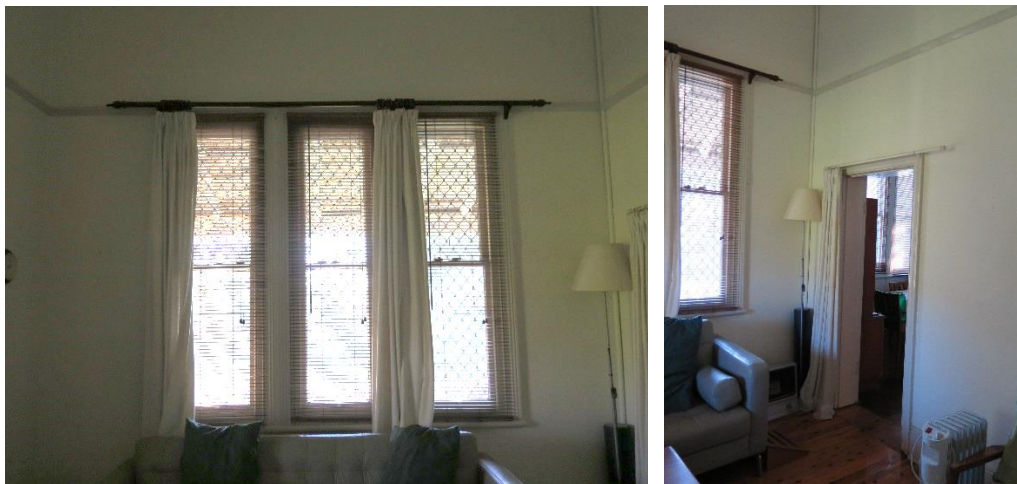
*Figure 46 — Caretaker's Cottage, living room with north-facing group of three, timber framed sash windows (left). The living room door (right) is narrow and possibly a later addition (Source: NBRSPARTNERS, July 2015)*

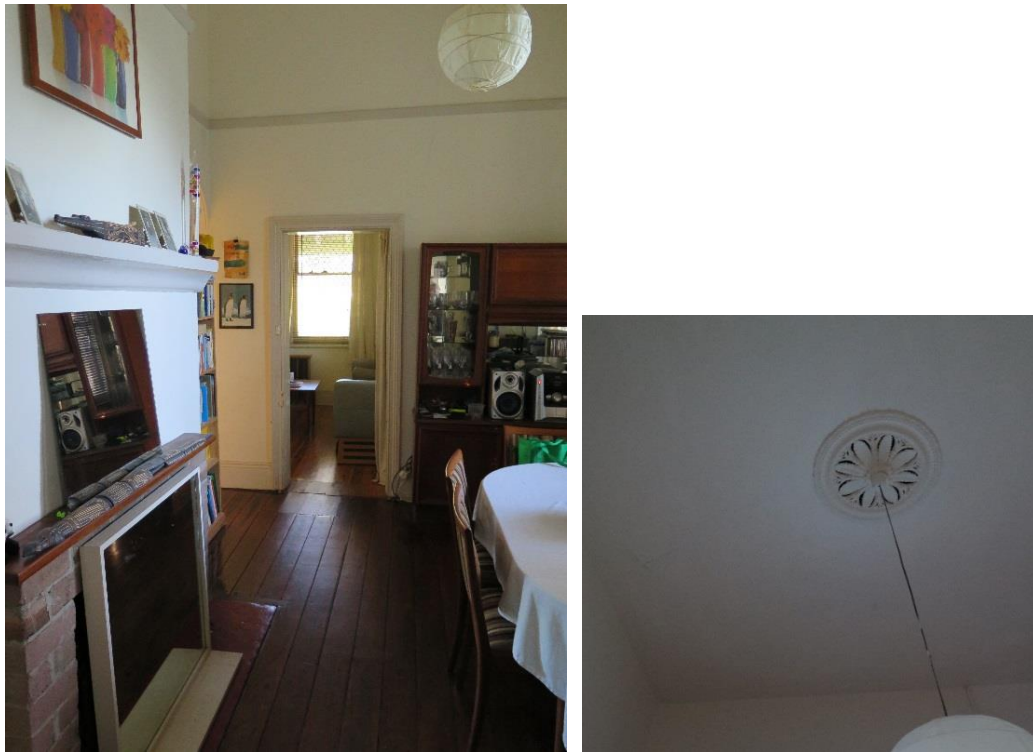
Figure 47 — Caretaker's Cottage, former kitchen, now used as dining room showing fireplace with brick surrounds (left). Decorative plaster ceiling roses are located in some of the original rooms (right) (Source: NBRS+PARTNERS, July 2015)

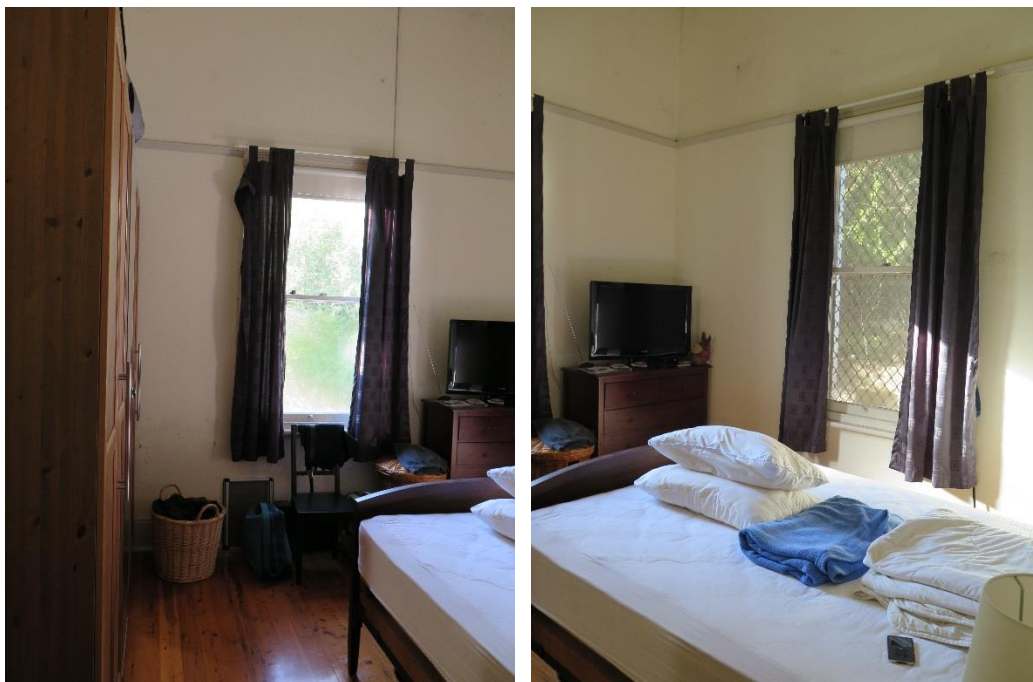
Figure 48 — Caretaker's Cottage, bedroom, located on south-eastern corner of cottage showing timber-framed sash windows on southern and eastern walls (Source: NBRS+PARTNERS, July 2015)

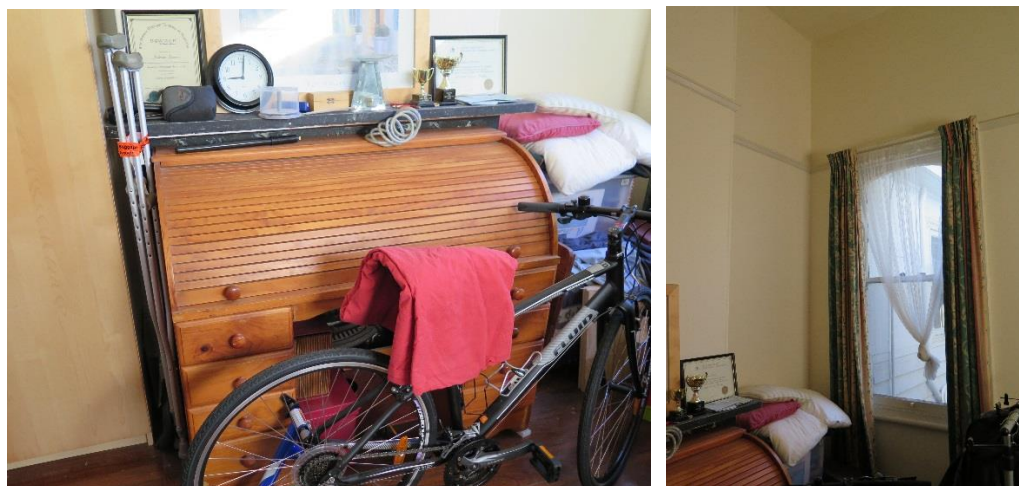
*Figure 49 — Caretaker's Cottage, bedroom adjoining the former kitchen, has a dark marble surrounds to fireplace (covered by furniture), timber picture frames and timber-framed, double-hung, sash window located on eastern walls (Source: NBRS+PARTNERS, July 2015)*

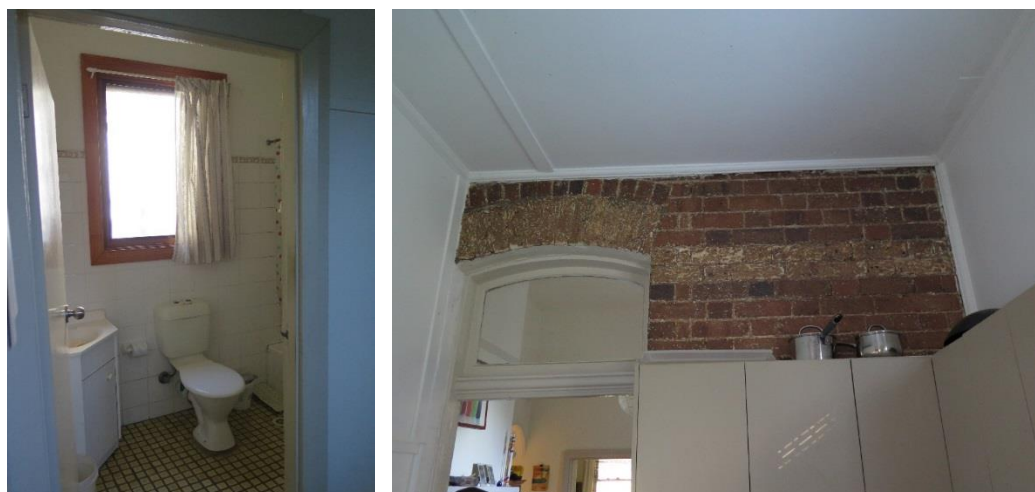
*Figure 50 — Caretaker's Cottage, eastern wall of kitchen shows the original back door and external face brick wall and fanlight over door opening (right). The kitchen, laundry and bathroom are later additions to the cottage. The kitchen ceiling appears to be clad in fibre cement. (Source: NBRS+PARTNERS, July 2015)*

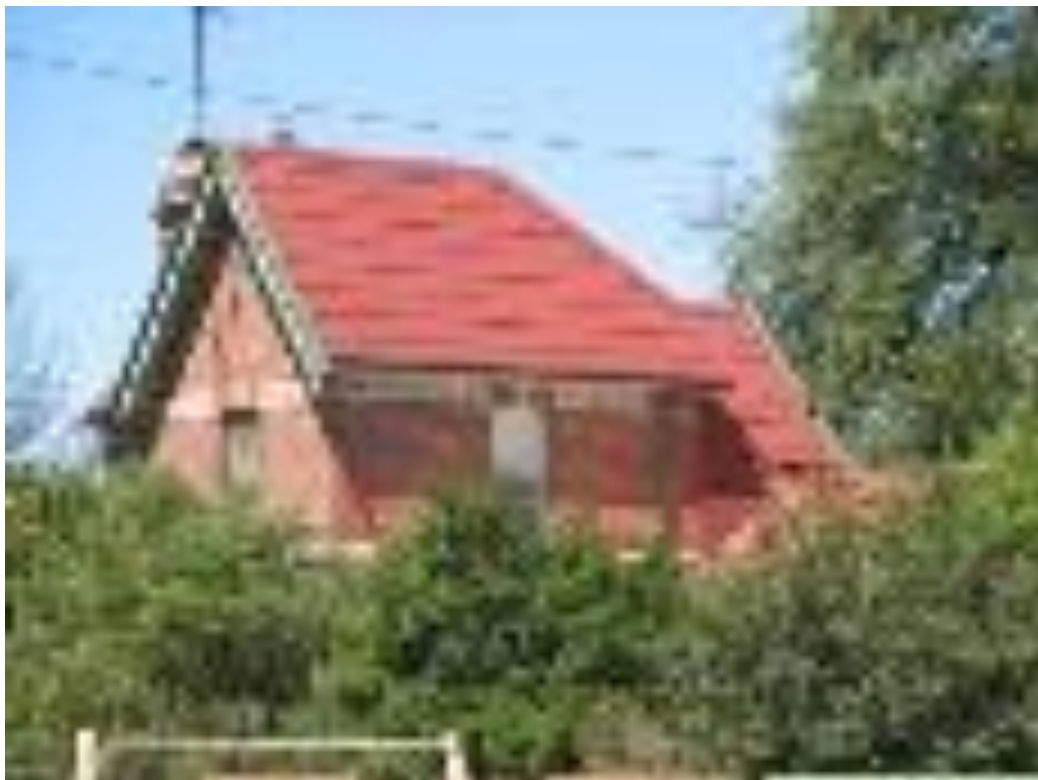
Figure 51 — Caretaker's Residence, Bathurst Showground, Kendall Avenue, Bathurst  
(Source: Office of Environment and Heritage, inventory sheet, Database No 1080292)

Caretaker's Residence at Bathurst Showground was purpose-built as a residence for the caretaker of the showground. The residence is a two-storey, Victorian Italianate residence of polychrome brick with a metal tiled roof. Asymmetrical massing dominated by a projecting two storey wing terminating in a faceted bay with a hipped roof topped by a wrought iron finial. Bay has D. H. sash windows, round arched to ground floor, flat arched to upper floor. Polychrome brick string courses add interest. Entry porch to side of bay has metal tiled roof and probably originally had decorative iron or timberwork.

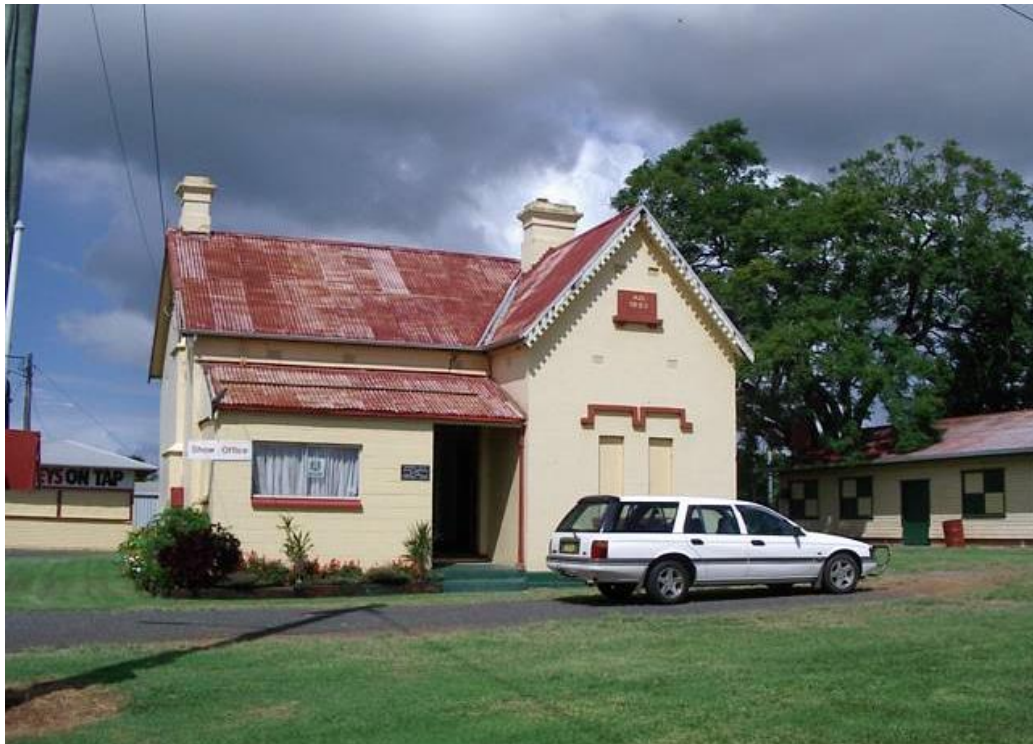
*Figure 52 — Caretaker's Cottage, Grafton Showground, Fisher Street, Grafton (Source: Office of Environment and Heritage, inventory sheet, Database No 1640207)*

The cottage was built in 1882 for Mr Rudolph Schafer, caretaker of Fisher Park and responsible for creating the botanical gardens at the site. Rudolph was the son of Rudolph and Anna Schafer, German migrants who arrived in Sydney in 1855 and who subsequently worked at Kirchner's Soap and Candle Factory. Later Rudolph Snr bought 5 acres of land beyond the Grafton racecourse, grew tobacco and made cigars. Bricks for the cottage were sourced nearby as there was a good supply of clay in Fisher Park and a kiln was established.

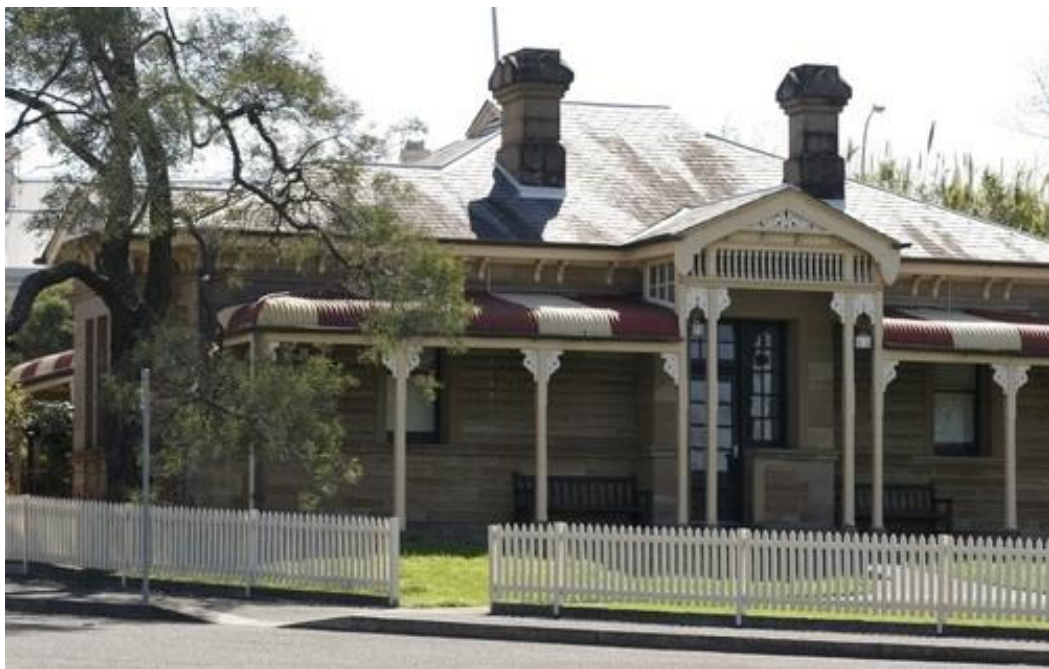
*Figure 53 — Superintendent's Residence, Centennial Park, Paddington Gates, Oxford Street, built in 1890-91 as the principal residence for the park manager (Source: Centennial Parklands website)*

Originally built in 1890-91 from sandstone quarried from the site, the Superintendent's Residence was built as the home of the senior on-site manager and his family as a purpose-built domestic house. The building offers a superb view down Parkes Drive and across Centennial Park. More recently, the Superintendent's Residence has been used primarily as a temporary exhibition space.

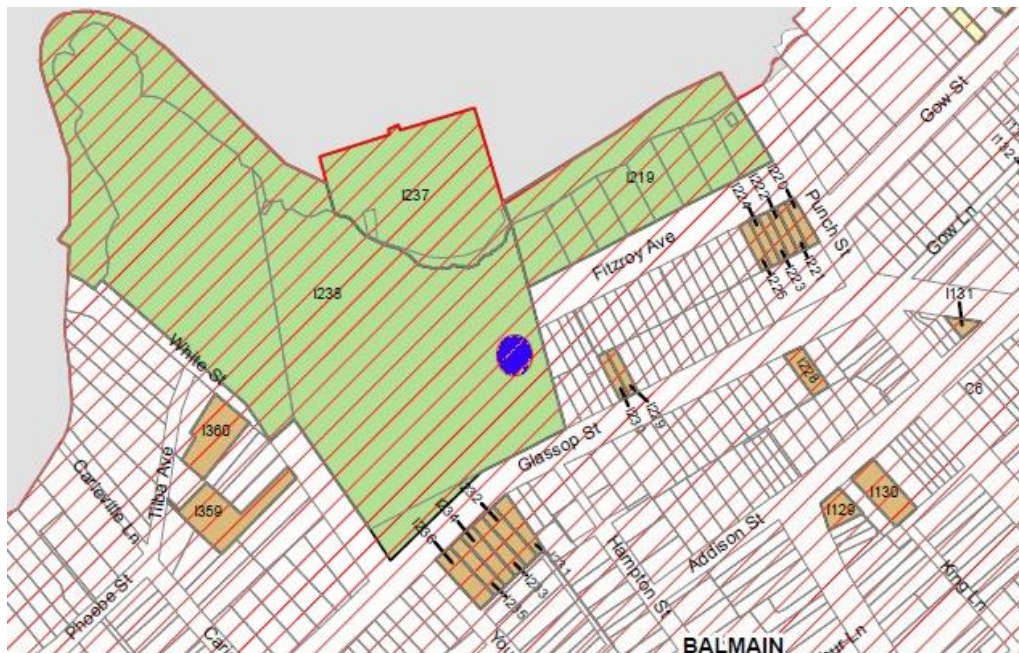
Figure 54 — Heritage Map showing the location of the Caretaker's Cottage identified by a blue circle. Heritage items (general) are identified in ochre and given a listing number, heritage items (landscape) are shaded in green and given a listing number and the conservation area is hatched in red (Source: Leichhardt LEP, Heritage Map 006)

There are a number of heritage items of local significance located in the immediate vicinity of the Caretaker's Cottage (see Figure 54). In addition, Elkington Park is located within the following conservation area of Local significance, identified in the Leichhardt LEP, Schedule 5 Environmental heritage, Part 2 Heritage conservation areas as follows:
