Appendix A

HISTORICAL ANALYSIS

ZONE 1 - EXISTING CONDITIONS

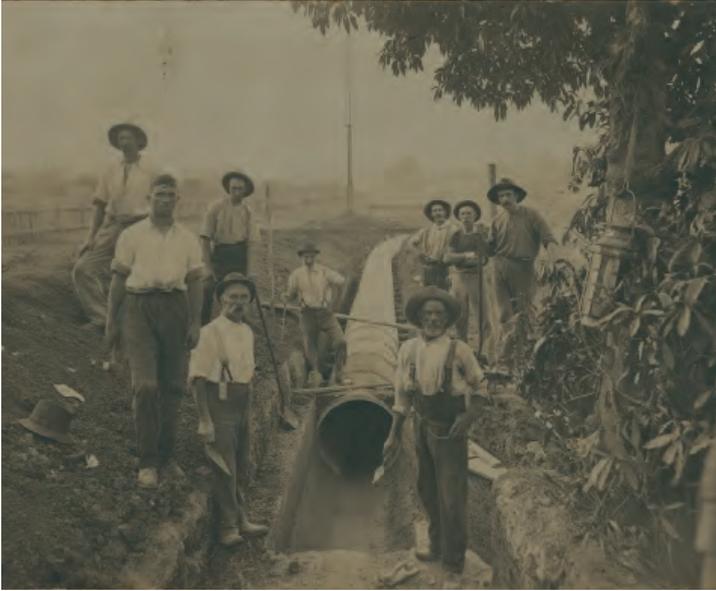
01

01. Drainage works for Pratten Park undertaken in 1910 / 02. The Davis Cup on Display at Pratten Park in 1939
03. Poster Advertising Autodrome at Pratten Park / 04. Salvation Army Youth Carnival at Pratten Park in 1948.
05. Photograph of cycling at Pratten Park. Ashfield & District Historical Society Collection, courtesy Barry McDonald

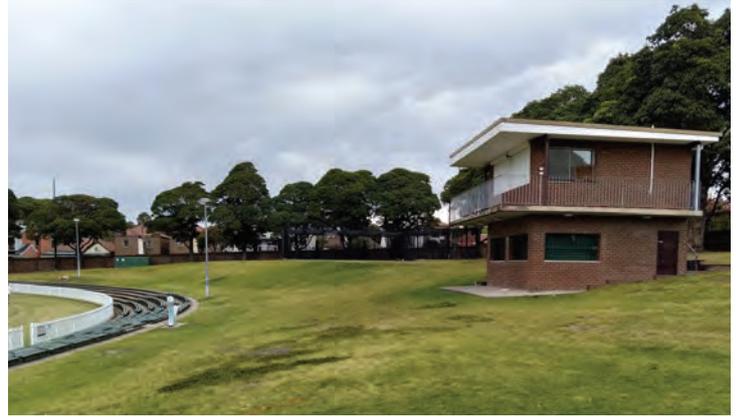
Zone 1 -View south to commentary box .

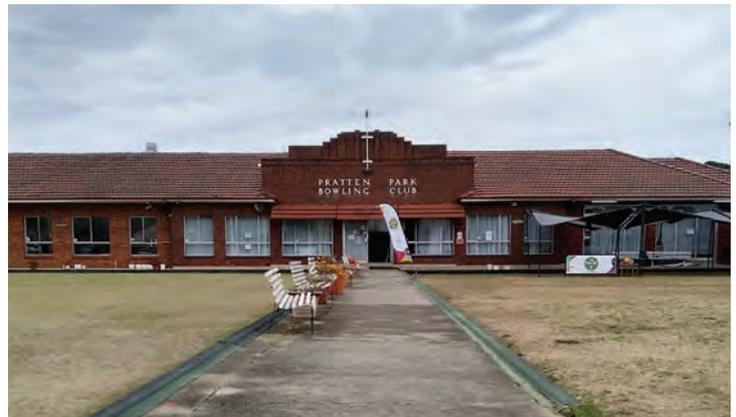
Zone 2 -View to Pratten Park Bowling Club from Arthur Street.

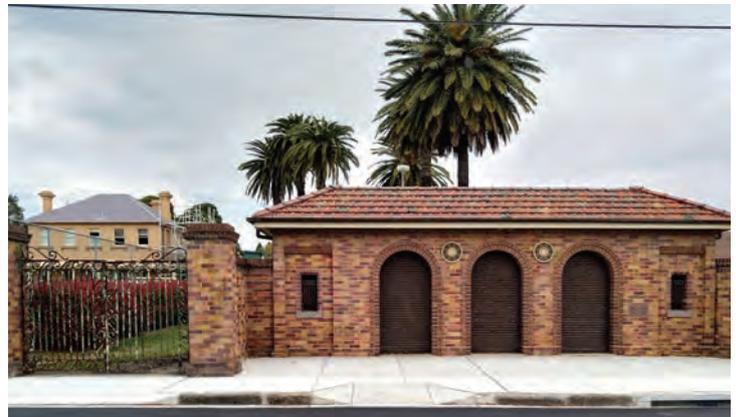
Zone 3 -View to north-east turnstiles and Thirning Villa.

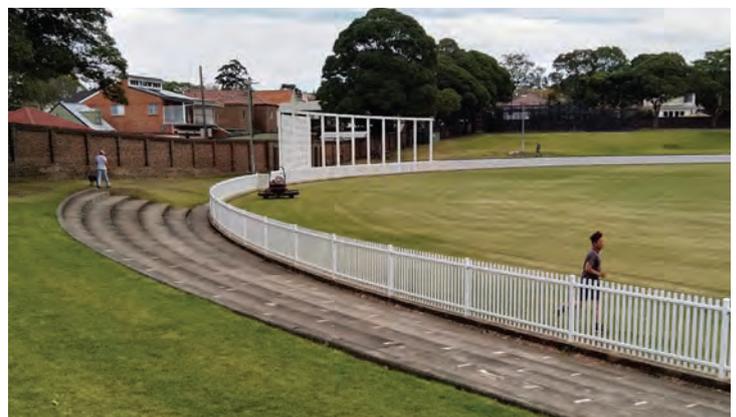
Zone 4 -View south towards Park Lane entry gates.

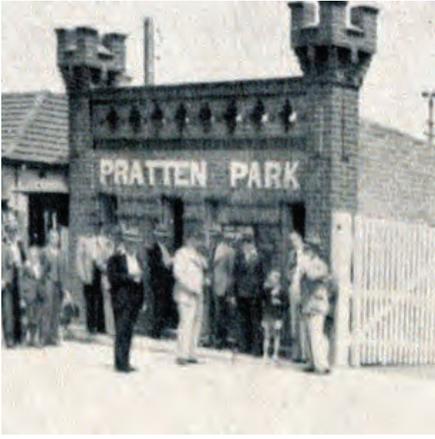
01

The current north-west Arthur Street gate, including the turnstile house, appears to date from the 1970s. It replaced an earlier Victorian Tudor style turnstile house (1921), which had the appearance of a medieval castle, later modified to remove the battlements (1950s-60s). The current gatehouse is a bland replacement, lacking the flair and place-making identity of its predecessors.

01. Original Turnstile House / 02. Modified Turnstile House / 03. Current turnstile House / 04. Existing driveway and parking / 05. Playground equipment and shade structure / 06. Playground interface with bowling club / 07. Front area of grandstand, view towards bowling club and bicycle lockup area / 08. Grandstand, view to the north / 09. Southern end of driveway and interface with change room facilities / 10. Existing bench seating around oval / 11. Commentators Box and canteen / 12. View west across grassed areas covering underground tanks. View to cricket nets beyond.

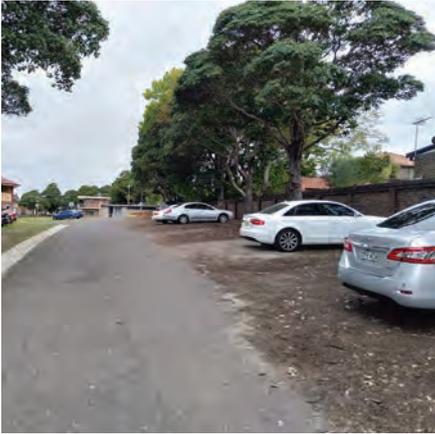
04

Paved areas around the Arthur Street entry are typically concrete slab and have been recently replaced. There is a long asphalt driveway which permits vehicle access to the park. The road surface is in a poor condition. Both sides of the driveway are used as informal vehicle parking and the resulting ground condition is very poor, consisting of patched grass and dirt.

The zone provides the only area for public parking on site. Vehicle access is via the gates on Arthur Street. Parking is informal, with vehicles parking perpendicular to the driveway, in between or in front of the trees and on the grass. This generally leaves the ground in a poor condition and limits vehicle capacity. Formalising the parking while maintaining permeable surfaces could be investigated.

- Improve the surface condition of the driveway through using durable surfaces. This could include permeable paving to facilitate car parking whilst allowing water to drain effectively and enter the soil around the existing trees.

- Improve the condition of the grounds around the trees and grassed areas by limiting vehicles accessing these areas.
- Improve the current car parking capacity by defining formal parking spaces. This would also assist in protecting the existing trees from damage of vehicles parking over their root base.

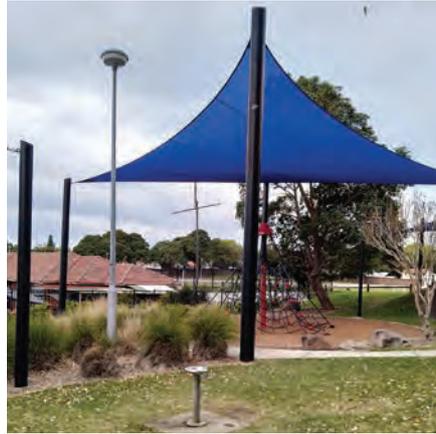
05

There are a mix of ground surfaces within the playground which are in an acceptable condition. The remainder of the zone is typically grassed. Some areas of grass over the underground water tanks are in very poor condition.

- The current playground is in an acceptable condition, however it could offer a more diverse play experience, such as 'wild' or creative play, or accessible play equipment.

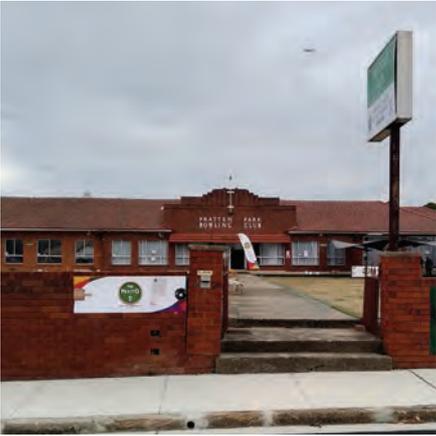
01

There are multiple signs identifying the bowling club. The most effective of this is the lettering on the bowling club itself which directly contributes to the heritage character of the club. There are also smaller metal signs fixed to the Arthur Street boundary wall in a similar fashion to the newer signs located at the park entries. There is also a large beer sign affixed to a high metal pole at the entry gate at Arthur Street. There is also a metal sign indicating 'The Pratto' Cafe. This sign does not give much information regarding the cafe and it can be difficult to tell when the cafe is operating from the street.

There is haphazard signage associated with the parking spaces and permitted uses of the park along the eastern boundary of the bowling club that should be removed and consolidated.

01. Arthur St entry gate with existing signage / 02. Historic gable end and lettering / 03. Interface with playground / 04. Existing shade structures used for dining and events / 05. External area at western corner used for storage and waste / 06. Lean-to structure along the south western edge of the club / 07. View along the southern boundary of the bowling club. 08, 09 Example of events that occur at the bowling club, including markets and live music - 'Music Fest' November 2018. Photo courtesy of Pratten Park Bowls Club.

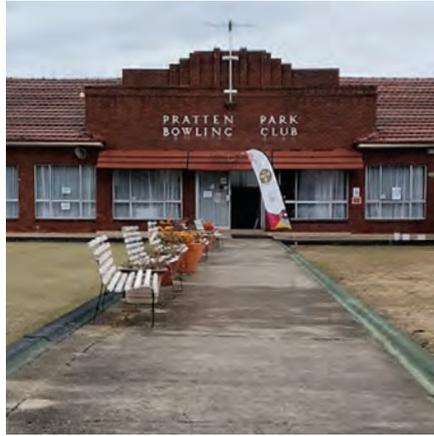
02

The bowling club itself began as a modest pavilion in 1913. The original pavilion was demolished and rebuilt in 1939. The Art Deco gable parapet at the midpoint of the building is likely a remnant of this structure.

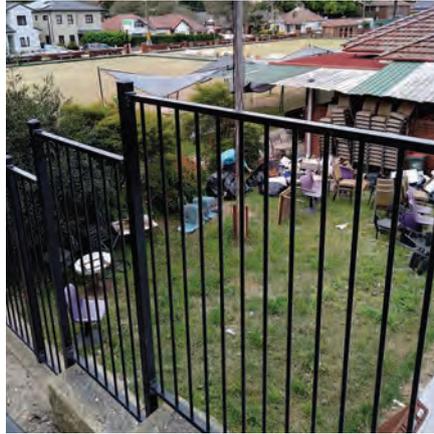
05

To the south-west corner there is a fenced off grassed area and lean-to which is currently used as a storage area and garbage dumping area, which degrades the overall impression of the club.

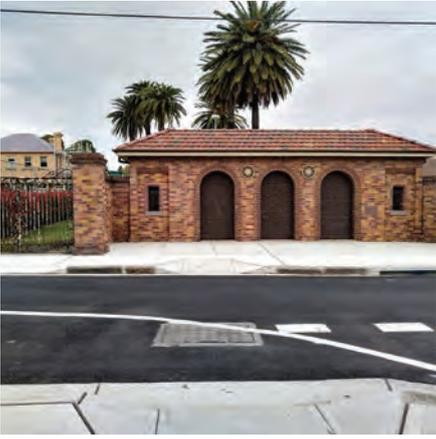
01

The turnstile house to the eastern entry of the park was constructed in 1933 and has significant heritage and place-making value. Its defining features include the triple round-arched entrances, textured brickwork, low-pitched terracotta tiled roof and wrought iron gates.¹ It is a highly valued park asset which has been neglected and is in need of sympathetic restoration. Areas of the brickwork appear to have cracked and parts of the ornamentation have been damaged. A Hazardous materials report carried out in 2015 detected lead paint and asbestos within the structure. The building is currently used for storage of sporting equipment.

01. View from Arthur St to eastern turnstile house / 02. Damage to existing turnstile house / 03. View east along Arthur St demonstrating tennis court interface with the street and grass strip / 04. Pedestrian entry adjacent turnstile house / 05. View south along Informal pedestrian path to bowls club / 06. View south along driveway to palm trees / 07. View north to sculpture garden and driveway, with turnstile house beyond / 08. Entry gate to Thirning Villa and tennis courts / 09. Rear of Thirning Villa, with interpretive tile design / 10. Rear of Thirning Villa, used for equipment storage / 11. Dilapidated sheds at the rear of Thirning Villa / 12. View north to Thirning Villa - note the metal gate and low fencing along retaining wall.

- Repair and restore the existing eastern turnstile house and park entry gates, which have significant heritage value. Remove hazardous materials.
- Improve the pedestrian entry to the park through surface and gateway upgrades.

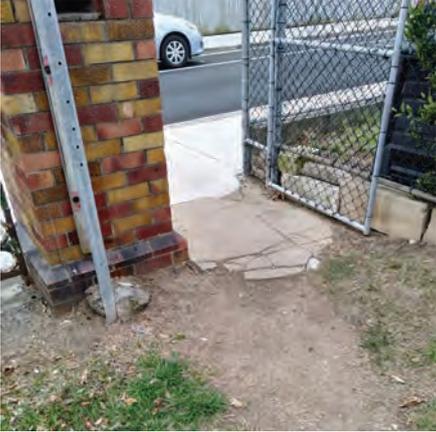
04

There is no dedicated pedestrian pathway, with the gate leading to a broken grass path, eventually resulting in pedestrians using the driveway. The driveway itself is problematic, with the compressed entry point and large brick piers restricting views between cars entering or existing and pedestrians.

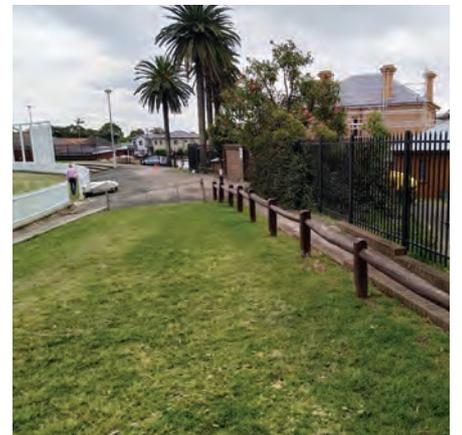
12

A low metal gate to the south of the zone prohibits vehicle access beyond the driveway to the south. It is in poor condition and also would make it difficult for some pedestrians to pass, particularly those

A low timber log fence runs atop the retaining wall adjacent the ramp to the toilet block, presumably as the retaining wall poses a fall risk. It is in poor condition. A white metal picket fence surrounds the oval which includes a vehicle access point. It is in good condition.

- Remove inconsistent signage and establish a clear and unified signage strategy for the park.
- Improve the interface between the boundary of Thirning Villa and the park itself through planting and fence upgrades.

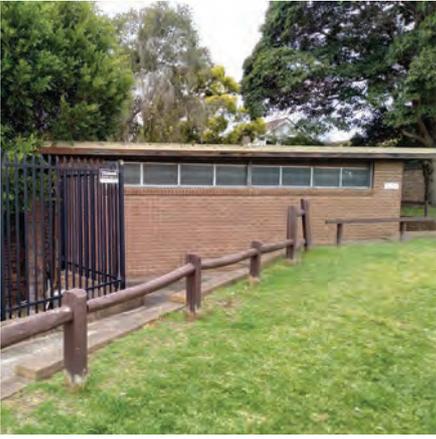
01

There are two separate male and female toilet facilities within the zone which sit along the eastern boundary and have been disused for some time. The structures are in a poor condition, with visible signs of damage. Access to the toilets is via a thin concrete ramp which involves a sharp 90 degree turn, likely making wheelchair access difficult. The buildings do not appear to have any architectural or historical value.

01. View to existing female toilet block / 02. View south to male toilet block and scoreboard / 03. View to entry of male toilet block entry / 04. Existing park furniture / 05. Area behind scoreboard / 06. View to the south, with tiered concrete steps without bench seating / 07. View to north, with bench seating / 08. Park lane entry gates / 09. Pedestrian entry gates / 10. View to the west along southern boundary wall / 11. View to scoreboard / 12. Maintenance garage with access to Park Lane.

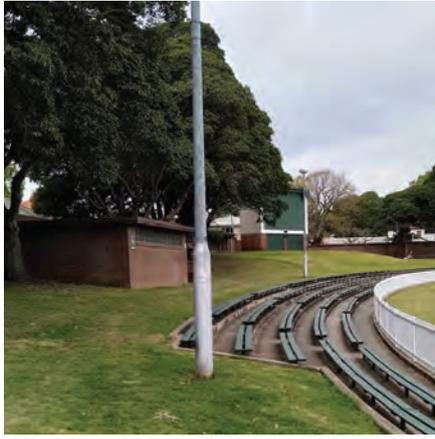
02

There is a two-storey scoreboard at the south-east corner of the oval which was constructed in 1953. It houses an electronic scoreboard and is in an acceptable condition. Its location within the park creates a small pocket of space directly behind the scoreboard which is somewhat hidden from view, which is potentially problematic.

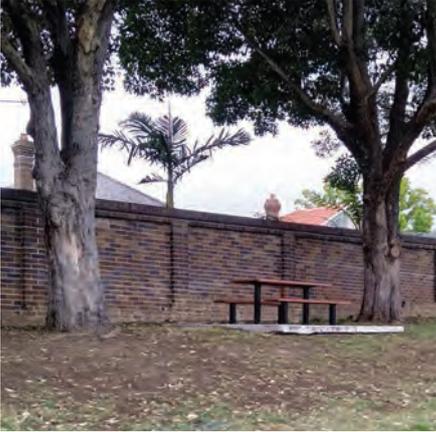
04

There is a double bench and table midway along the eastern boundary of the zone. It is in an acceptable condition however the concrete footings have become exposed, and the location of the seating is questionable.

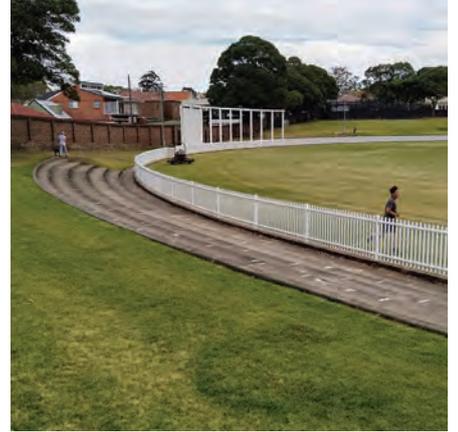
06

The tiered seating to the east of the oval is currently in poor condition, with some benches in a state of disrepair. Some rows have been completely removed. However it should be noted that the timber bench style of seating has a pleasing appearance that contributes to the heritage quality of the oval.

There are tiered concrete steps which run around the perimeter of the oval and form the foundation for the seating, which is sometimes used as a makeshift path by walkers and joggers.

- Repair existing timber bench seating. Retain the style of the bench seating which is well suited to the character of the oval. Avoid the use of single plastic chairs.

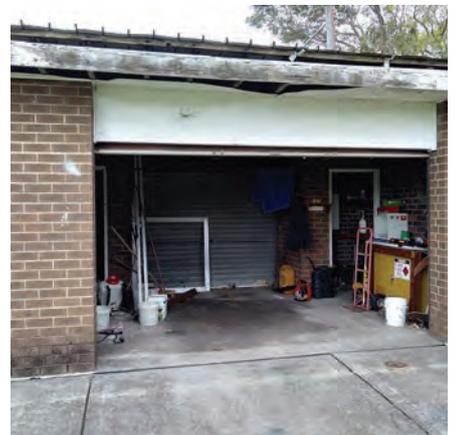
12

There is a service garage and storage shed at the south-eastern corner, which has both access to the park and the laneway via metal roller doors. It was likely constructed at a similar time to the toilet facilities. Parts of the building are in a fairly poor condition with visible signs of damage.

- Address the area to the rear of the scoreboard which is out of sight and poorly maintained. This could involve planting or screening the area.
- Investigate the use of the existing storage shed. Repair the existing service shed which is in a damaged state if it is still required. Determine whether any additional storage is required.

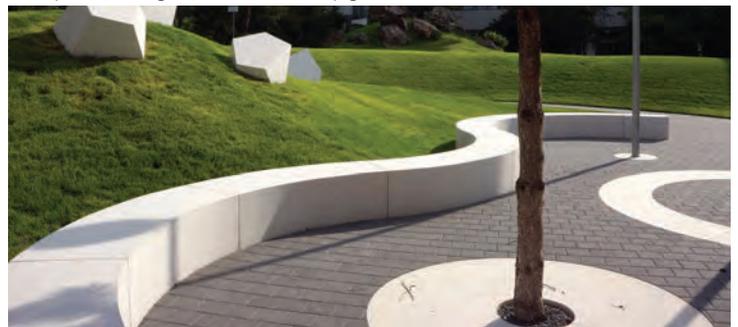
Curved concrete seating wall - example of seating around basketball area.

Concrete retaining walls are proposed for areas with a change in level and are to act as both an informal seat as well as to retain areas of planting. Concrete is to be poured or pre cast concrete with burnished finish and penetrative anti graffiti coating.

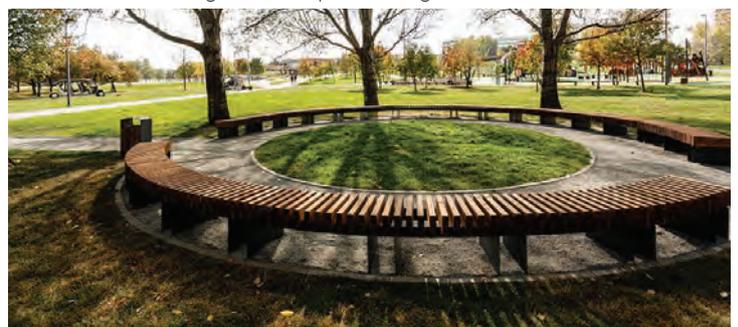
Curved timber bench seat for around base of existing trees and planting.

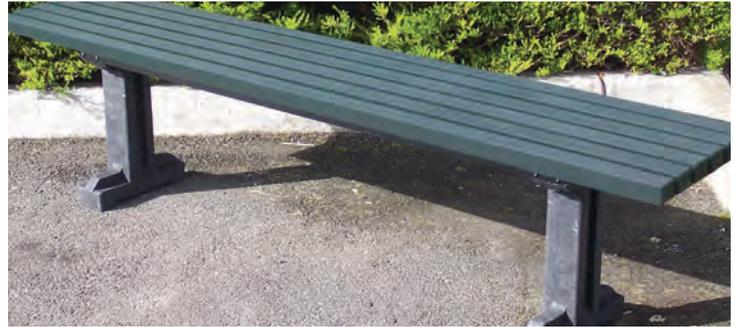
Where existing timber tiered bench seating is in need of replacement and cannot be restored and repainted, recycled plastic lumber of an appropriate colour could be considered as a replacement to reduce ongoing maintenance.

Sample of plastic lumber alternative for tiered bench seating.²

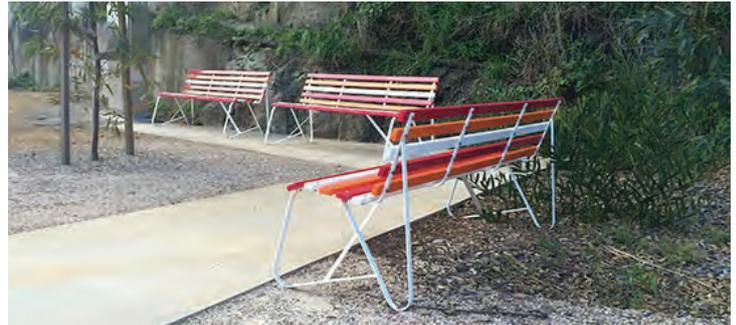
Existing Tennis court / Bowling club benches.

Restoration and paint finish to existing benches.

Example of playful colour palette for existing timber benches around tennis courts.

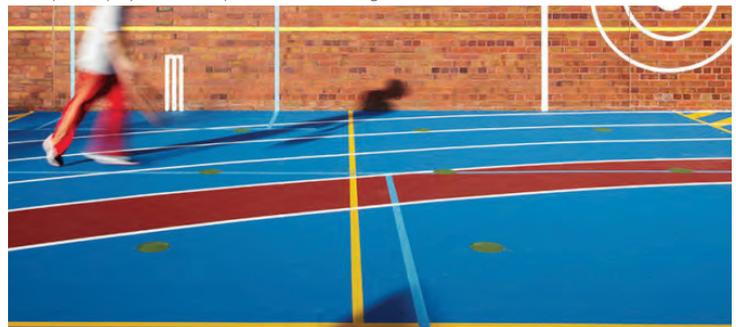
Oval running track / informal sports area

Synthetic surface, colour mix to complement the park.

Colourful multi-purpose sports + activity area with contrasting running track.

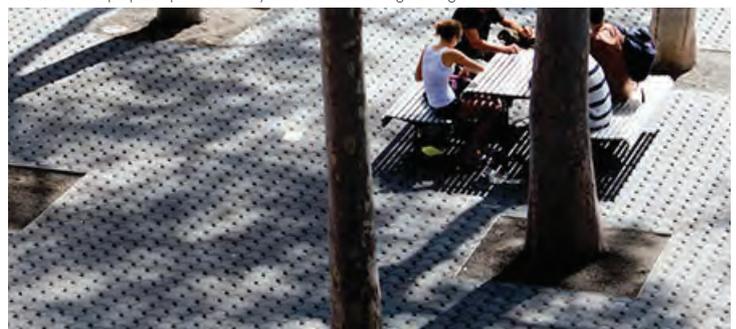
Min 80mm thick concrete permeable paving units, finish to achieve required slip resistance rating. Sub-base and drainage to paving manufacturers requirements.

Sample of permeable paving with integrated trees.

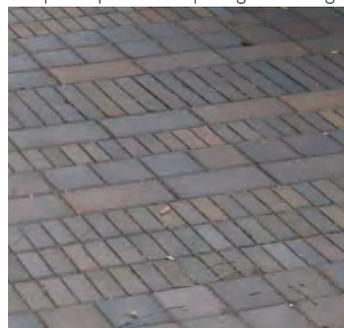
Concrete pathways, depth and reinforcement to engineers requirements. Sandblasted or broom finish with no edge treatment to achieve required slip resistance rating. Incorporate recycled dry pressed bricks feature paving and elements on concrete base.

Mixed format brick feature paving.

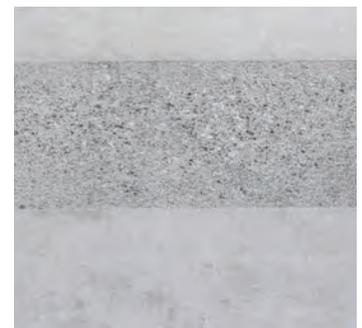
Sandblasted concrete pavement.

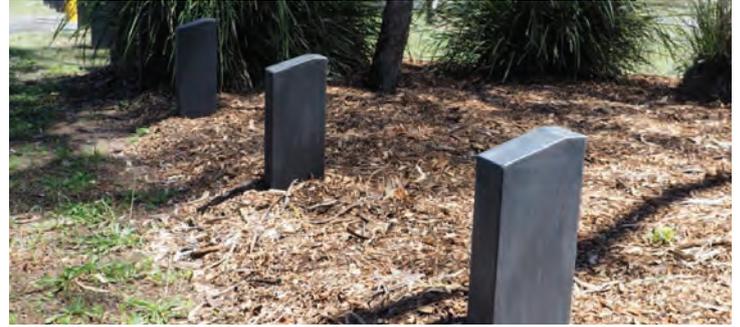
Spaced, low bollards of a dark plastic lumber product for durability and ability to blend into surrounding planting.

Sample of dark plastic lumber bollards for car park areas.

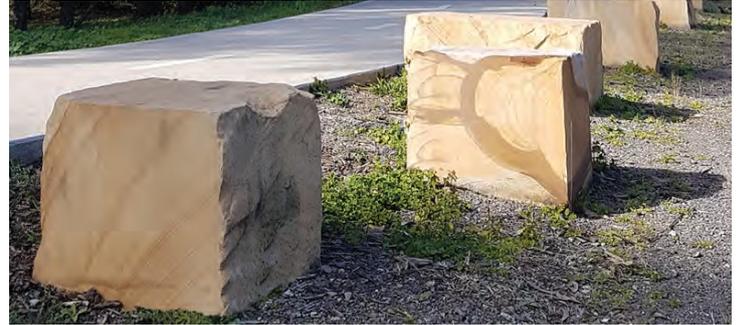
Rough sandstone blocks / boulders can also be employed to limit parking in garden areas where a row of bollards is not practical or desired.

Sandstone blocks to protect larger trees and raingardens within carpark.

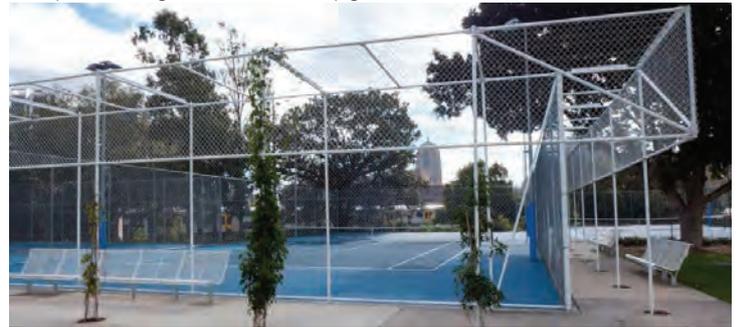
Example of tennis court fencing becoming arbour.
