Inner West Council area and suburbs. Recreation Needs study - A Healthier Inner West.

ZONE 1 - EXISTING CONDITIONS

ZONE 2 - EXISTING CONDITIONS

ZONE 3 - EXISTING CONDITIONS

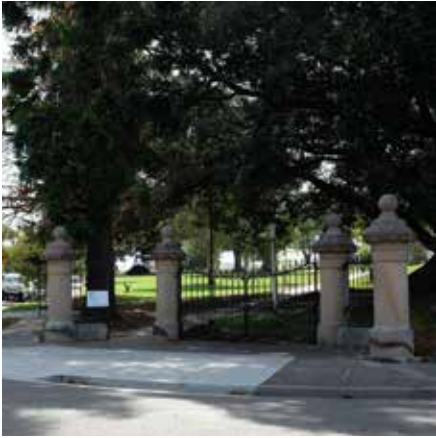
01

There are sandstone gate posts and wrought-iron gates at the north-western corner of the park. These are engraved 'the park'. The sandstone gates which mark the south-western entry point were relocated from the Schuldhall Estate, Croydon, built during 1860.

01. Original park gates at the intersection of Pembroke St / Orpington St / 02. Pedestrian Footpath / 03. Exercise station (north) / 04. Open parkland along Orpington St. 05. View back towards park gates / 06. Embankment alongside sporting ground, note seating and lighting / 07. Water tank below ground / 08. Tank equipment / 09. View to dressing rooms and scoreboard / 10. Shaded grassy areas alongside pedestrian pathway / 11. Seating alongside sporting ground. / 12. Exercise station (south).

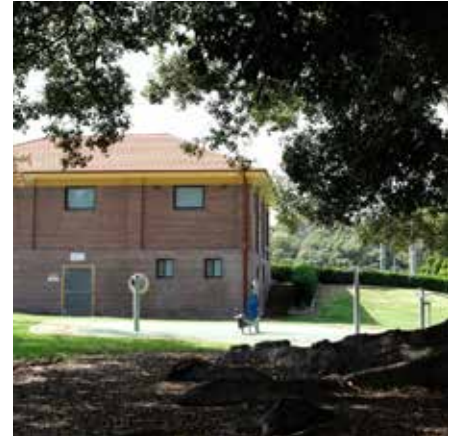
03

There is an exercise station close to the dressing shed pavillion with 4 pieces of equipment, which are in good condition. The south-eastern exercise station has 5 pieces of equipment is generally in good condition except for the sit-up station which is in need of repair. The stations are designed to appeal to a range of fitness levels and

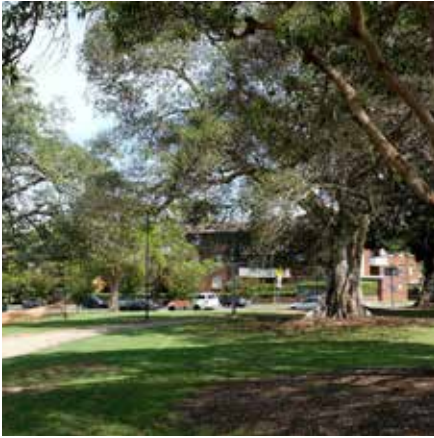
01

01. View to Orpington St entry along pathway / 02. Community garden / 03. Community garden raised planter / 04. View to bowling greens from community garden / 05. Ashfield Bowls Club building / 06. Picnic table beneath tree / 07. Memorial water fountain / 08. View to Parramatta Road and areas to the north of the driveway / 09. View along driveway to Orpington St / 10. Areas to the north of the bowling club / 11. View to the south-east along driveway / 12. View along Orpington St showing interface of bowling greens with street.

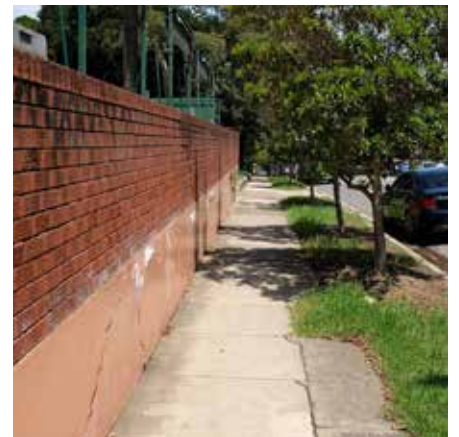
12

The bowling club as it stands today was opened in 1958, replacing an earlier structure. It appears to have undergone some minor modifications, such as the inclusion of solar panels on the roof. The bowling club faces south-west towards the greens, with the north-east side generally presenting back of house functions such as waste

- Install additional table and chair park furniture in well-shaded locations.
- Improve the street presentation of the bowling club perimeter wall along Orpington St.

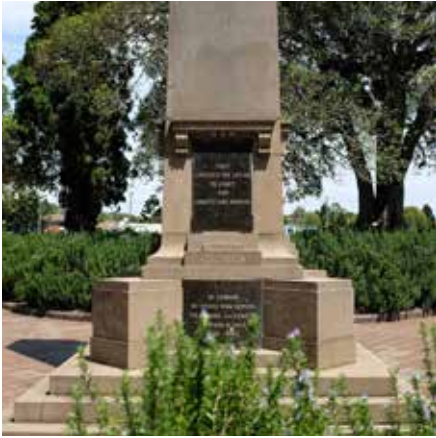
01

Paths generally lead to the centre of the park, where a circular path runs around the perimeter of the war memorial. This circular path is separated by steps from the war memorial forecourt itself. This generally leads to cyclists and some pedestrians using the perimeter circular path as they move through the park. A number of e-bike riders were observed riding along this circular path at speed, moving through the park between Gower St, Parramatta Rd and Loftus St.

01. View to war memorial / 02. Mother language monument / 03. Processional path to war memorial / 04. Jessie Stuart Bloomfield memorial water fountain / 05. Diagonal pathway through to Parramatta Rd. / 06. Large solitary eucalyptus / 07. exposed furniture and open grass areas / 08. View to Parramatta Rd and flag poles / 09. Parramatta Rd entry stair / 10. Rainbow Serpent carved tree / 11. Dr Jose P Rizal statue / 12. View along tree-lined pathway through to Parramatta Rd.

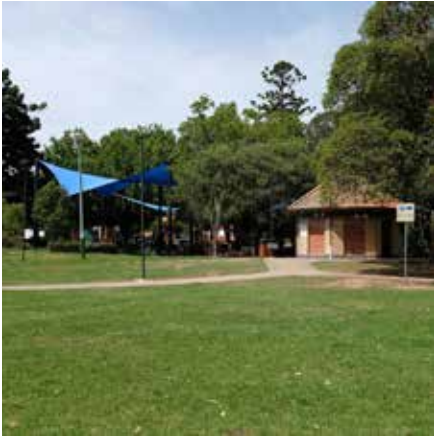
01

There is a small public toilet facility to the north of the playground. It appears to be in acceptable condition however there are signs indicating that female toilets are also located elsewhere in the park.

01. View south to public toilets and playground beyond / 02. View east to 'Begonia House' picnic shelter / 03. View inside picnic shelter / 04. Shady park bench overlooking the swing set / 05. Northern barbecue shelter / 06. Southern barbecue shelter / 07. View north to playground fencing / 08. View to Ormond St & Pembroke St entry / 09. View from Ormond St & Pembroke St entry / 10. Example of turpentine tree / 11. Playground equipment / 12. Mary Poppins memorial statue.

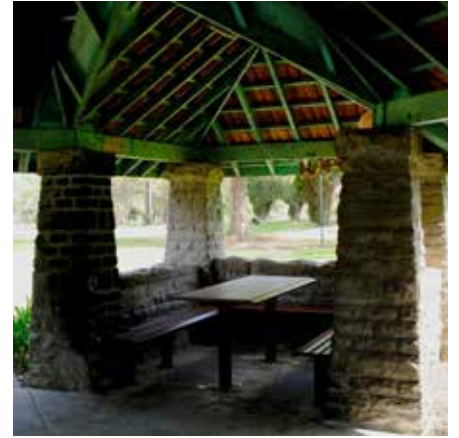
03

There is a well located single bench positioned beneath the shade of the fig tree adjacent the swing set. There are four picnic benches located within Begonia House, which are in good condition, having recently been replaced due to vandalism. There are two separate barbecue facilities close by, with two hotplates each. Both are sheltered by small pitched roofs.
