# Preliminary Geotechnical Investigation Report

75 Mary Street, St Peters, NSW

Report No. E22317 GA\_Rev3

18 September 2015

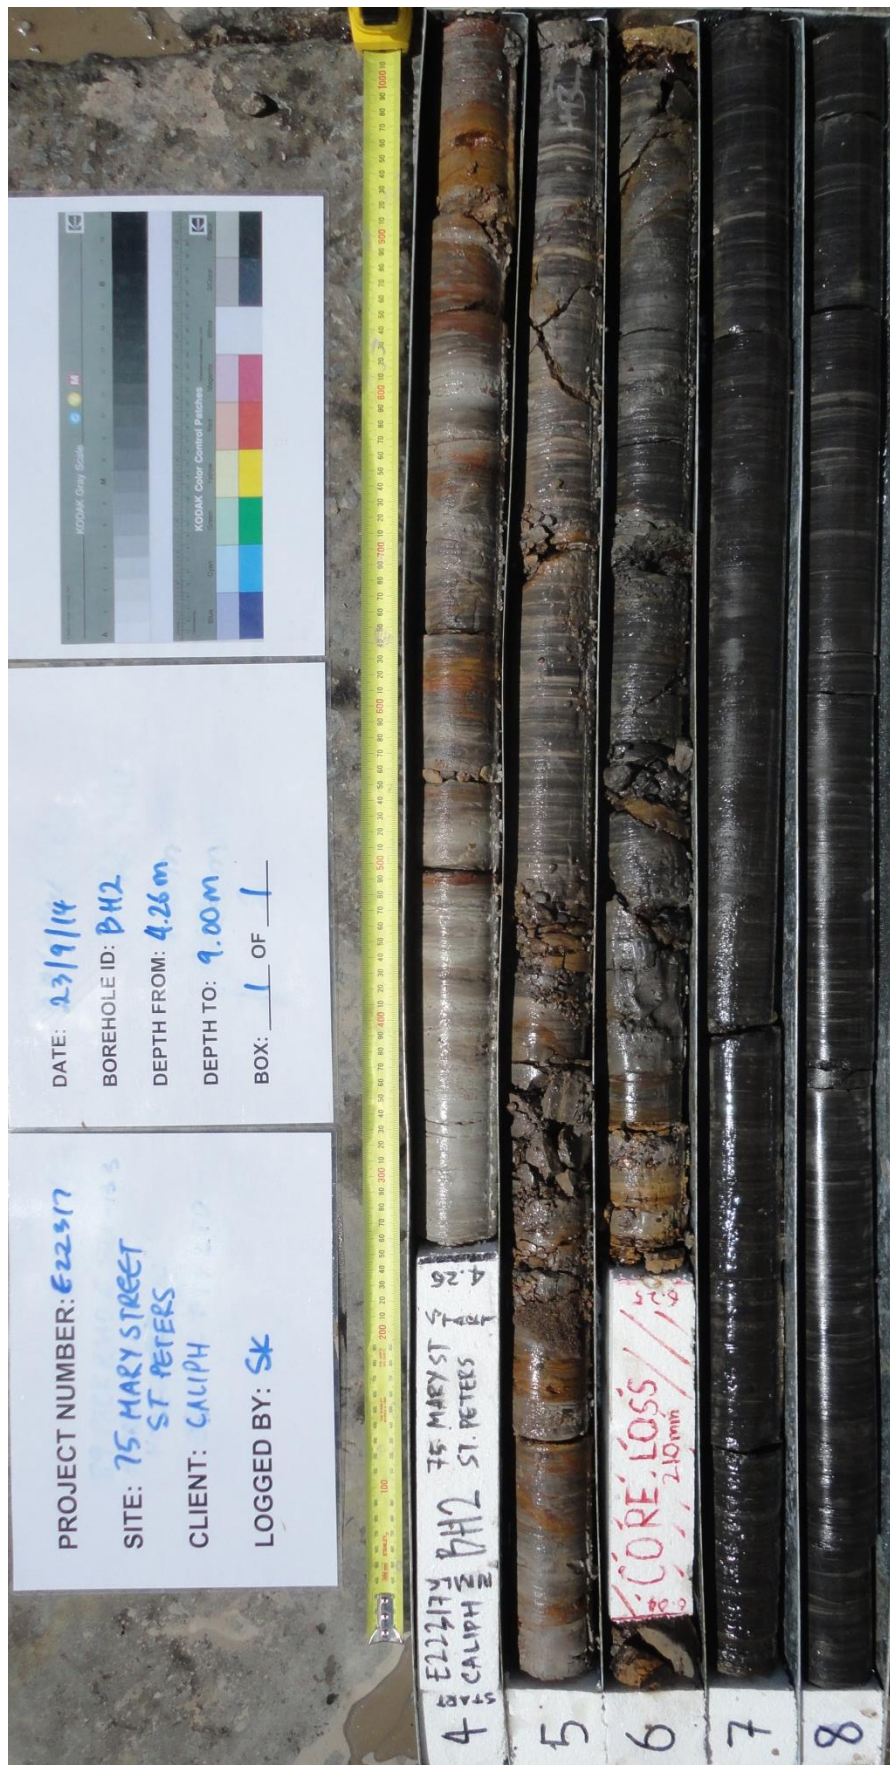
## REPORT OF BOREHOLE: BH2/MW2/ASS2

Project New Mixed Development  
Location 75 Mary Street, St Peters NSW  
Position Refer to Figure 2  
Job No. E22317  
Client Caliph

East 331107.4 m  
North 6245935.7 m  
Contractor Traccess Pty Ltd  
Drill Rig Multi-Drill 3000  
Inclination -90°

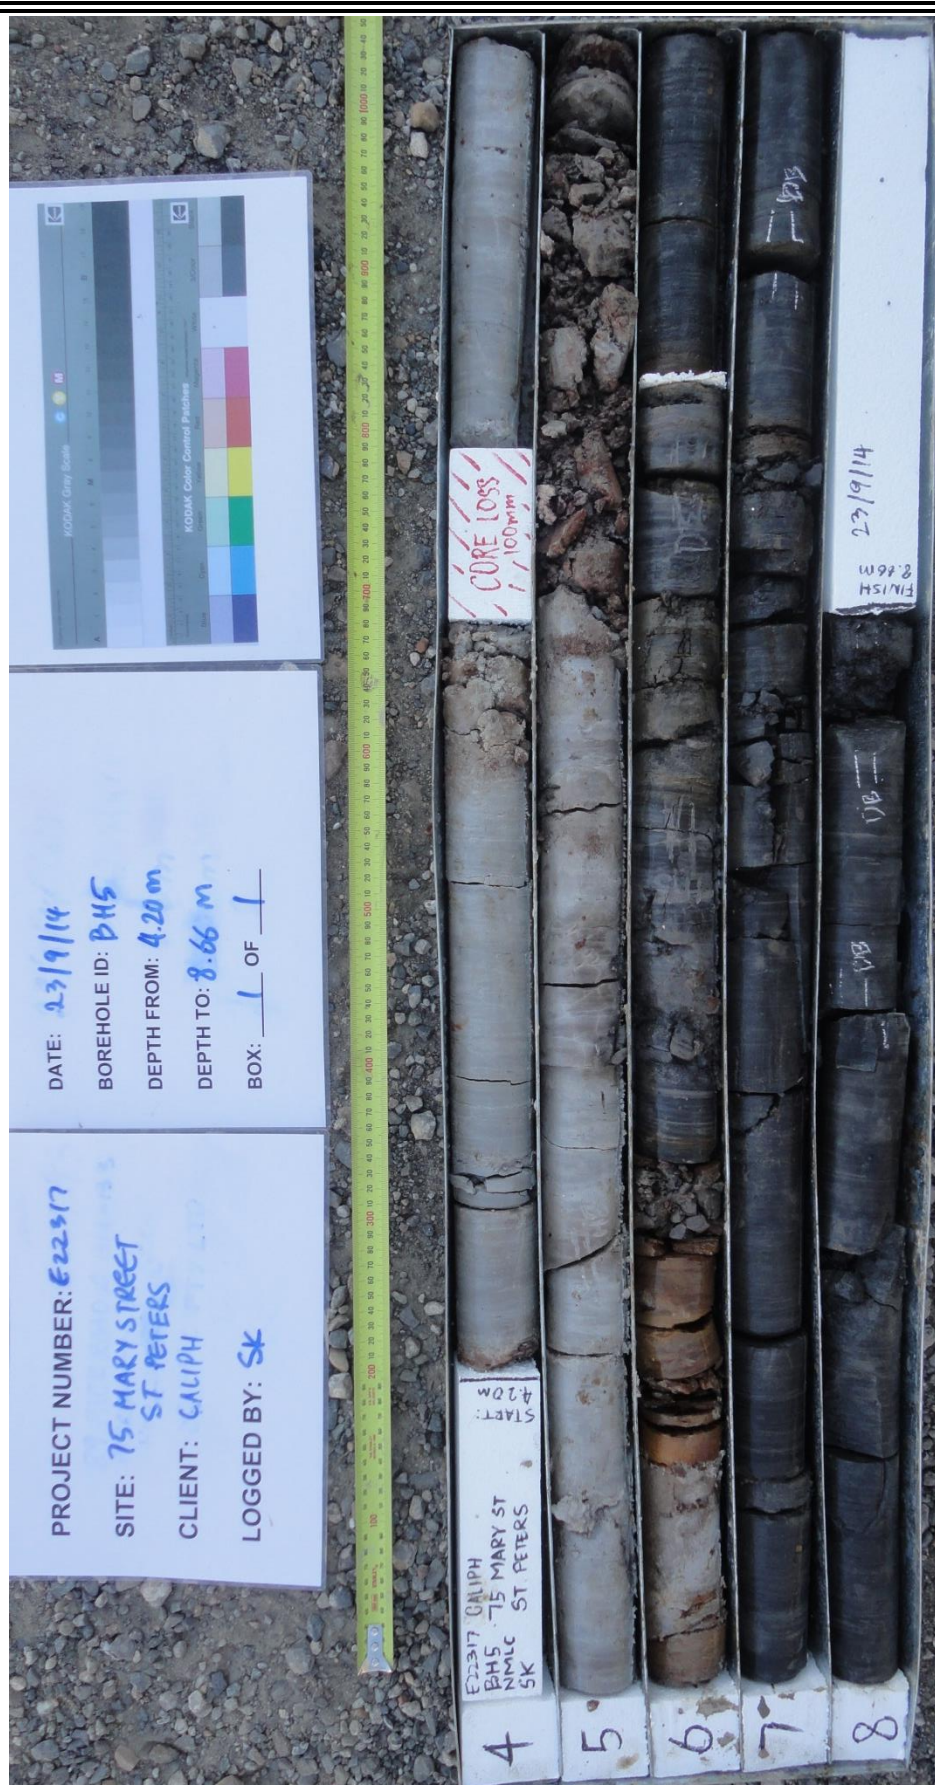
EAST: 331192.569 m  
NORTH: 6245953.870 m MGA94 Zone 56  
INCLINATION: -90°  
BOX: 1 of 1  
HOLE DEPTH: 8.66 m

DEPTH RANGE: 4.20 m to 8.66 m  
DRILL RIG: Multi-Drill 3000  
DRILLER: Traccess Pty Ltd  
LOGGED: SK  
CHECKED: AM  
DATE: 23/9/2014  
DATE: 9/10/2014-
