Appendix A

Site Analysis

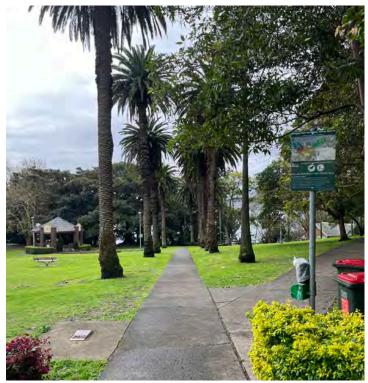
Zone 1 - View north along date palms

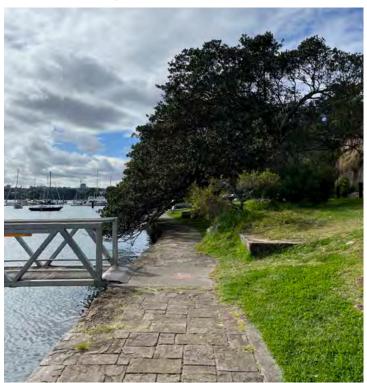
Zone 2 - View west along stone foreshore

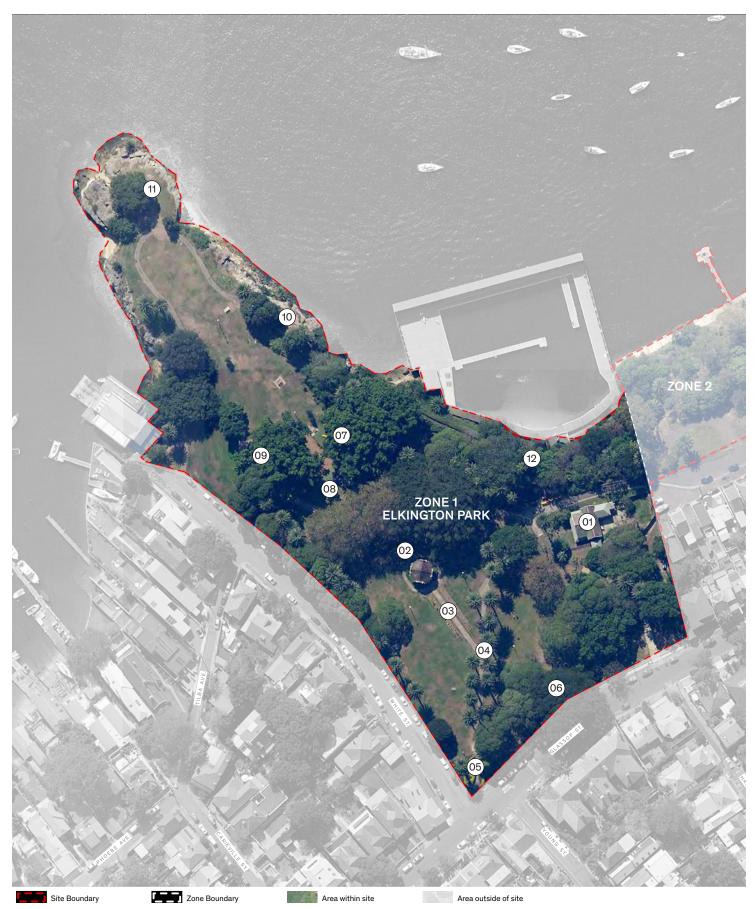
01. Vacant Caretaker's Cottage / 02. Rotunda / 03. Historical rose garden / 04. Date Palm tree grove / 05. Entrance garden + park sign / 06. Established Fig trees / 07. Fenced playground / 08. Open playground / 09. Amenities Block / 10. Natural cliff face + caves / 11. White Horse Lookout + furniture / 12. Staircase to Dawn Fraser Baths

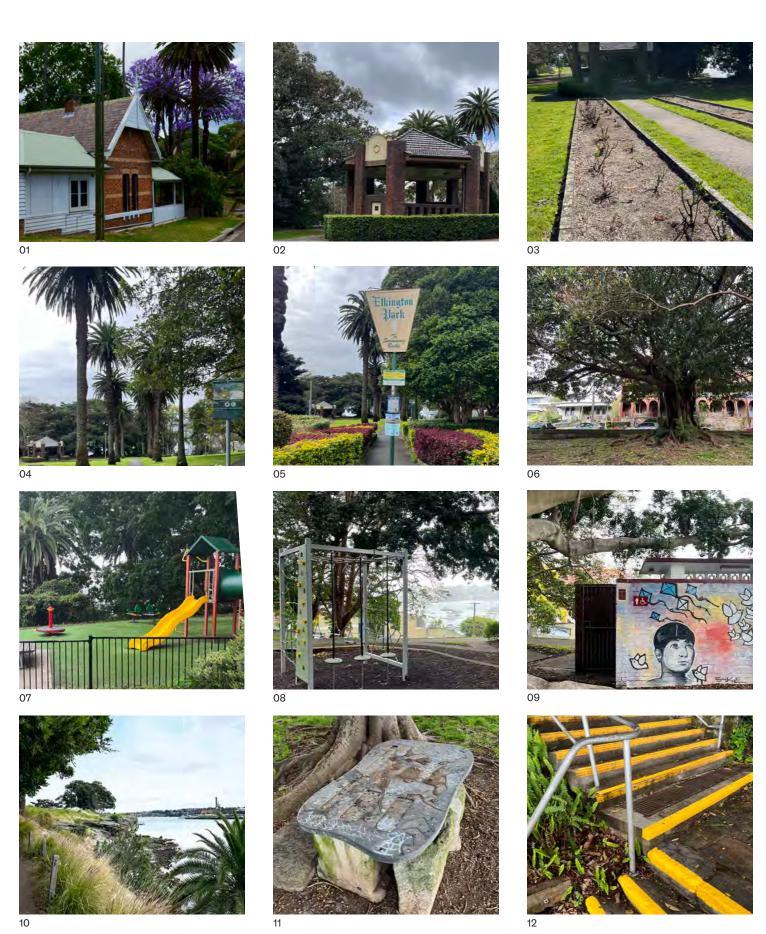
01. Vacant Caretaker's Cottage / 02. Rotunda / 03. Historical rose garden / 04. Palm tree grove / 05. Entrance garden + park sign / 06. Established Fig trees / 07. Fenced playground / 08. Open playground / 09. Amenities Block / 10. Natural cliff face + caves / 11. White Horse Lookout + furniture / 12. Staircase to Dawn Fraser Baths

- Upgrade + maintain the historically significant rotunda.
- Investigate alternative uses for the vacant care-takers cottage, including, but not exclusive to, relocated amenities, community space or cafe. Any future use which is determined by Council should be reflective of the wider community needs and maximise the use and enjoyment of the cottage by the wider community. Any proposed use should also be ancillary to the purpose use and enjoyment of the park as a whole Improve signage consistency throughout the zone.

- Establish a design for new signage that communicates the civic and historic character of the park.
- Install a park map at well selected locations. The park map should include a tactile section + section written in language of First Nations group. Clearly identify park assets and public toilet locations.

- Investigate diverse play equipment which caters to more age groups, including teenagers. Less specific nature play items should be considered.
- Upgrade park furniture + bubblers.

- Improve circulation by investigating new path connections.
- Investigate upgrades to existing amenities block.
- Investigate solutions to rainwater runoff to reduce pooling of water at White Horse Point.

- Establish new understorey planting to selected areas along the southern boundaries.
- Futureproof existing shade + shelter through planting of new
- Improve access to Dawn Fraser Baths

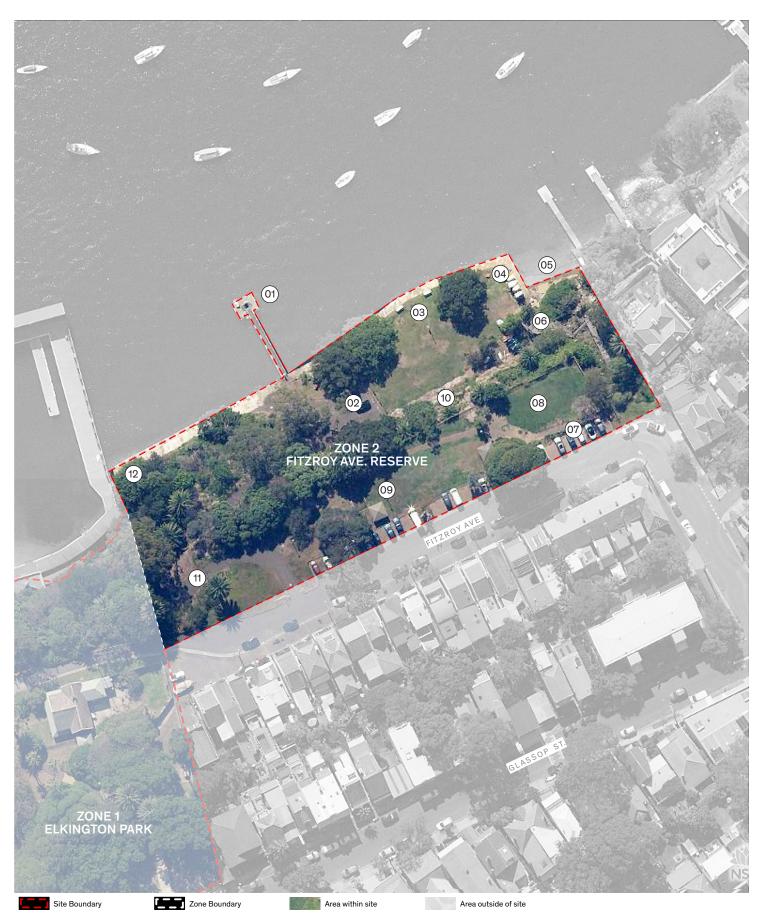
01. Jetty / 02. Accessible Carpark / 03. Sandstone foreshore / 04. Kayak + boat racking / 05. Harbour beach / 06. Timber staircase + walkway to Fitzroy Avenue / 07. Carparking along Fitzroy Avenue / 08. Seating area + lookout point to Cockatoo Island / 09. Shaded gazebo structures / 10. Sandstone escarpment / 11. Winding road to accessible carpark / 12. Rear entry point to Dawn Fraser Baths

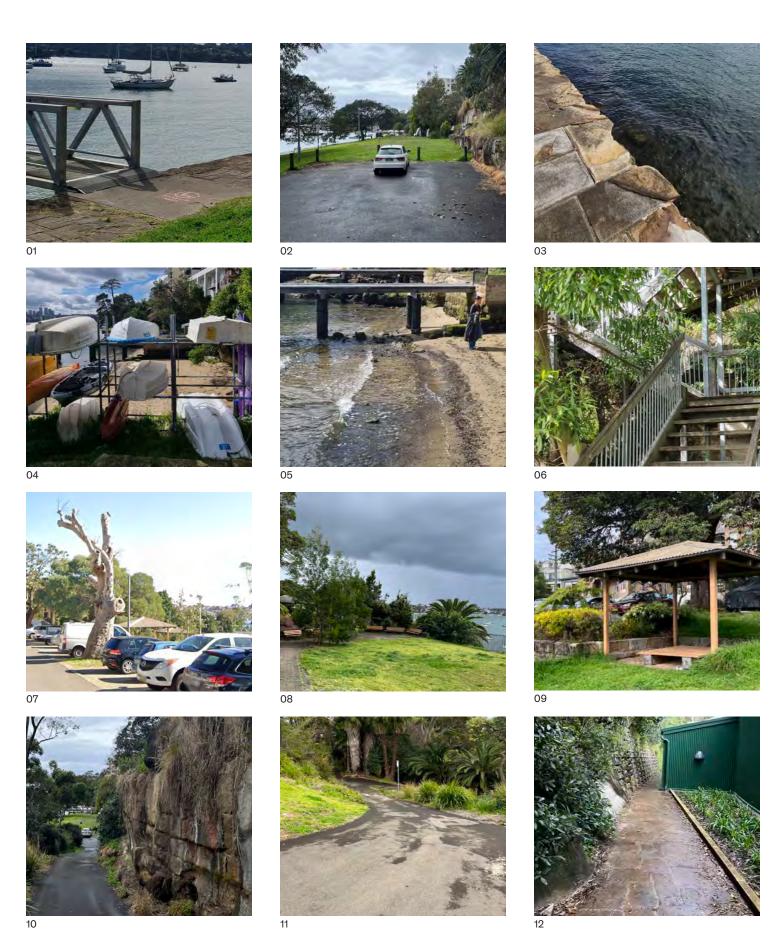
01. Jetty / 02. Accessible Carpark / 03. Sandstone foreshore / 04. Kayak + boat racking / 05. Harbour beach / 06. Timber staircase + walkway to Fitzroy Avenue / 07. Carparking along Fitzroy Avenue / 08. Seating area + lookout point to Cockatoo Island / 09. Shaded gazebo structures / 10. Sandstone escarpment / 11. Winding road to accessible carpark / 12. Rear entry point to Dawn Fraser Baths
