O3 Existing Facilities

MIDJUBURI WARD (MARRICKVILLE) - Existing Facilities

MIDJUBURI WARD (MARRICKVILLE) - Existing Facilities - Key Information

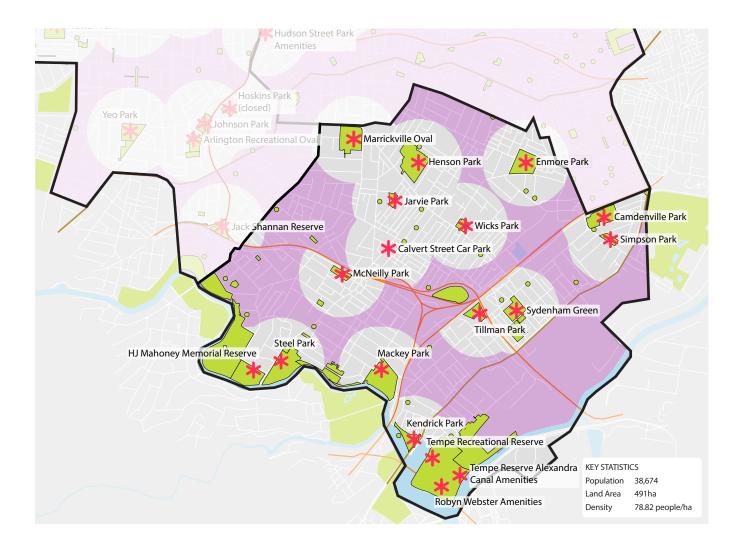
Marrickville Ward is bounded by Frazer Street, John Street, Newington Road, Enmore Road, Juliet Street, Lynch Avenue, Lynch Lane, Edgeware Road and the railway line in the north, the Princes Highway, the City of Sydney, Canal Road, Ricketty Street and the Alexandra Canal in the east, the Cooks River in the south, and Wardell Road in the west. Marrickville Ward encompasses the suburbs of Sydenham and Tempe, most of the suburb of Marrickville, the Inner West Council area part of the suburb of St Peters, and small parts of the suburbs of Dulwich Hill, Newtown and Petersham.
