Heritage Assessment

389 Illawarra Rd, Marrickville

Version 1.3

18 May 2020

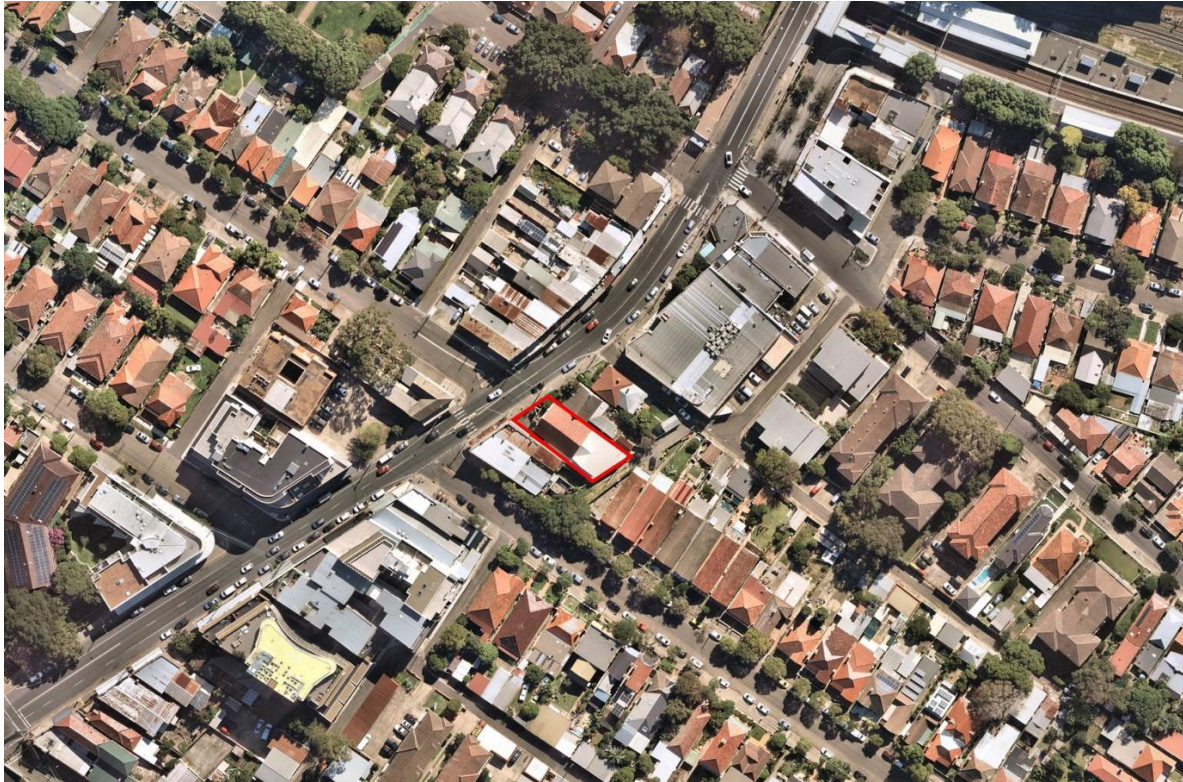
Figure 1: 389 Illawarra Rd, Marrickville (Source: NearMap.com with HAA overlay)

The boundary of the site is the boundary of land title Lots 4, 5 and 6, DP 2595.

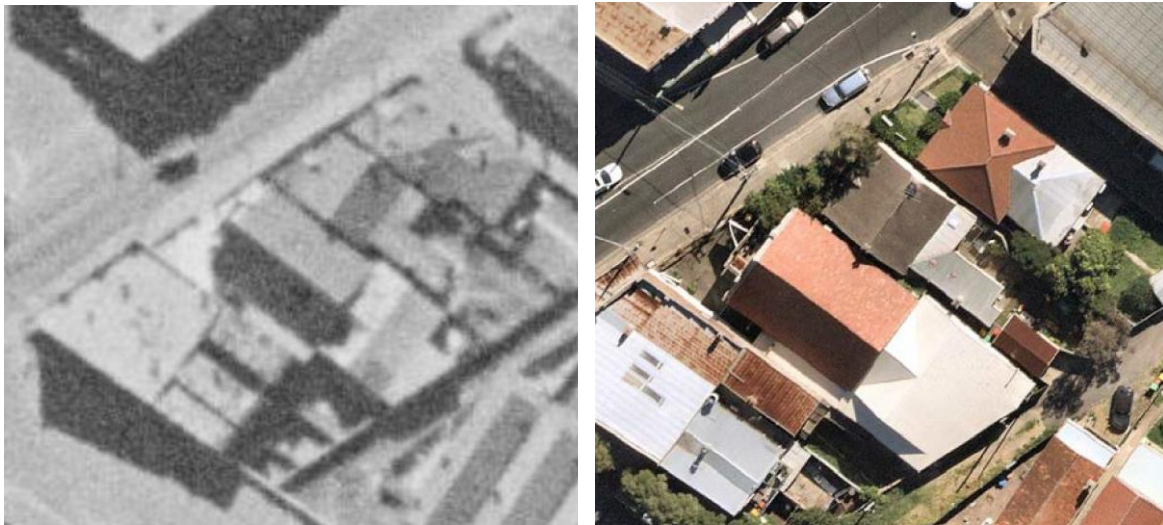
Figure 4: 1943 aerial image (left, maps.six.nsw.gov. au) and 2020 (NearMap.com). The present roof form appears to be similar to the 1943 form.

The nature of the hall before 1958 is unclear. A 1943 aerial photograph shows a similar roof form to that which exists today (see below). This may suggest that the structure of the original hall was retained in some form.

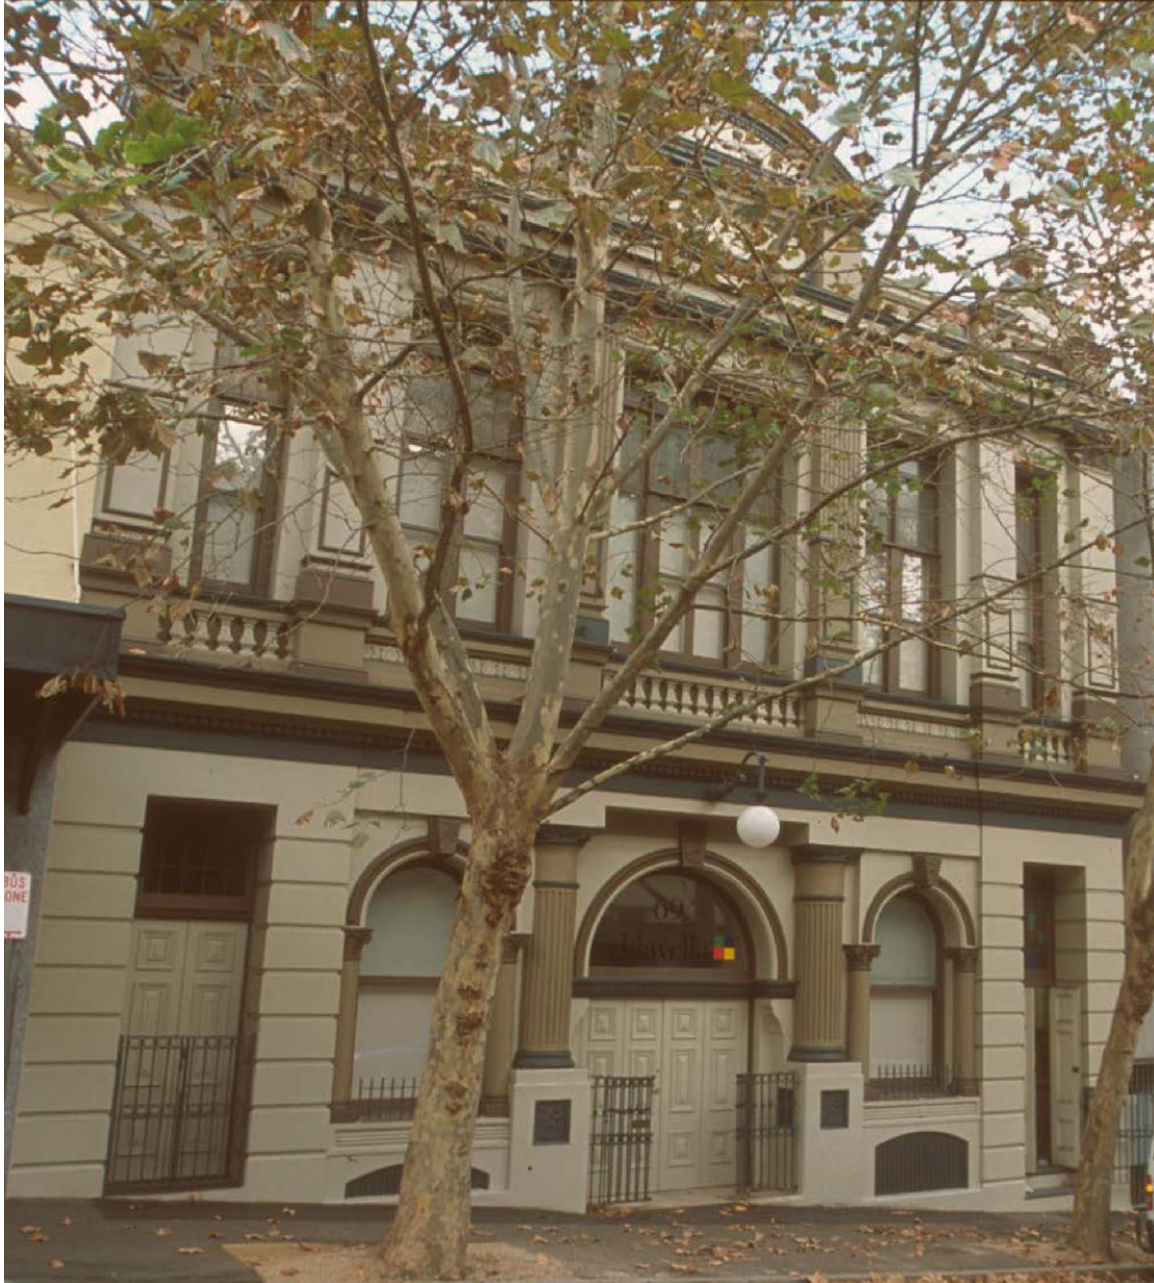
Figure 5: Former Freethought Building, 69 Campbell Street, Surry Hills, photographed in 2001.
Source: Photographer Mark Stevens, courtesy City of Sydney Archives A-01129883

The Sydney Church of Christ left its 1869 church building in Elizabeth Street (presumed demolished) for the former Freethought Hall, 69 Campbell Street, Surry Hills, in 1895. The building was sold into private ownership in 1983.⁶ Built in 1890, the former Freethought Hall is still standing but does not have any physical characteristics that denote its former use as a Church of Christ.

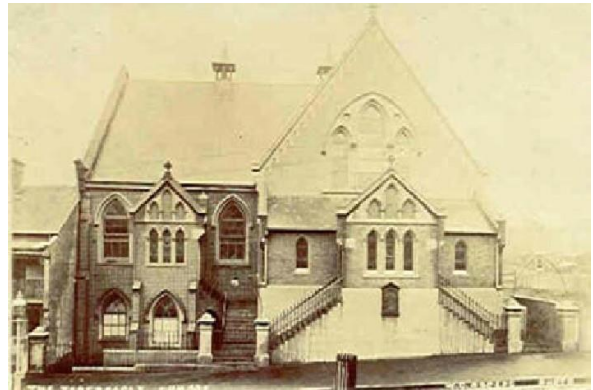
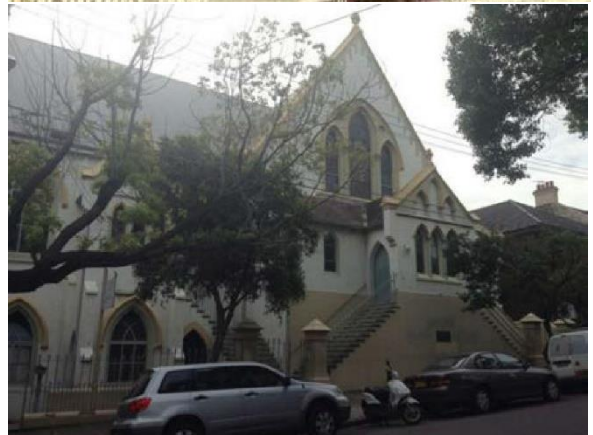
Figure 6: Enmore Tabernacle. Above, circa 1903 (source Maston: 310); Right top, post-1905 (source Inner West Council Library Service; Robert Hutchison, donor); Right bottom, present-day appearance (source State Heritage Inventory)

The Enmore Tabernacle, 17-21 Metropolitan Road, was constructed in 1886 and enlarged in 1905. It is currently used as a Seventh Day Adventist Church.

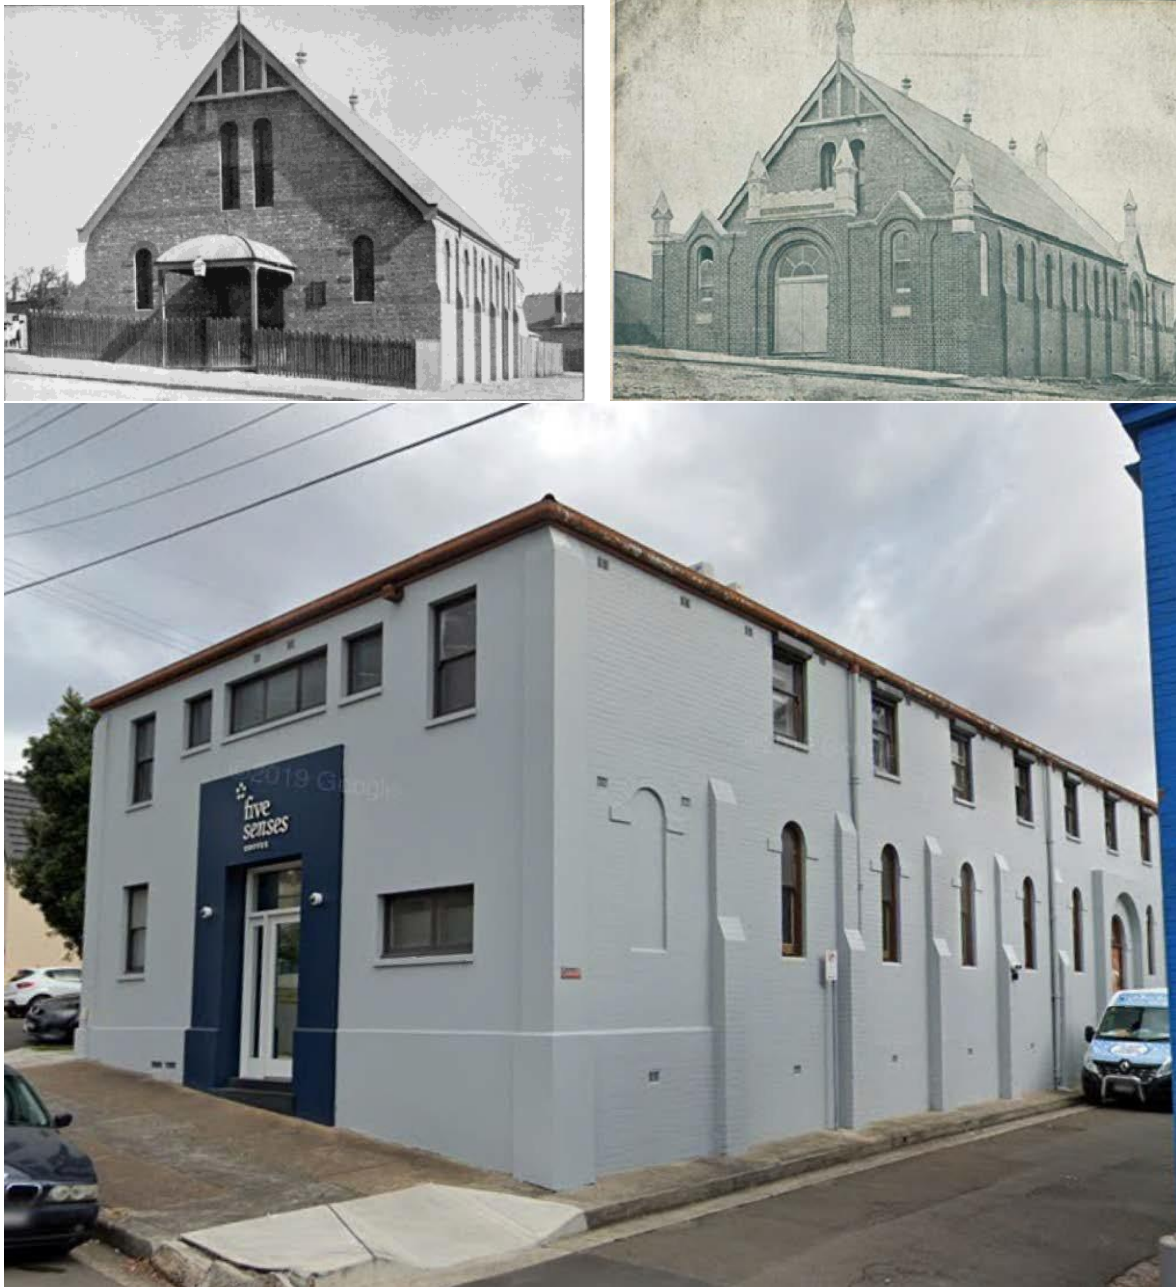
Figure 7: Petersham, top left: circa 1903 (Maston: 327). Top right: circa 1915. (Inner West Council Library Service; Robert Hutchison, donor) Bottom: August 2019 (Google)

Tenders for the construction of the Petersham Church, 2a Cannon Street, were called by John Halliday in June 1885.⁷ The building was enlarged by 1915, and is now in commercial use, substantially altered.

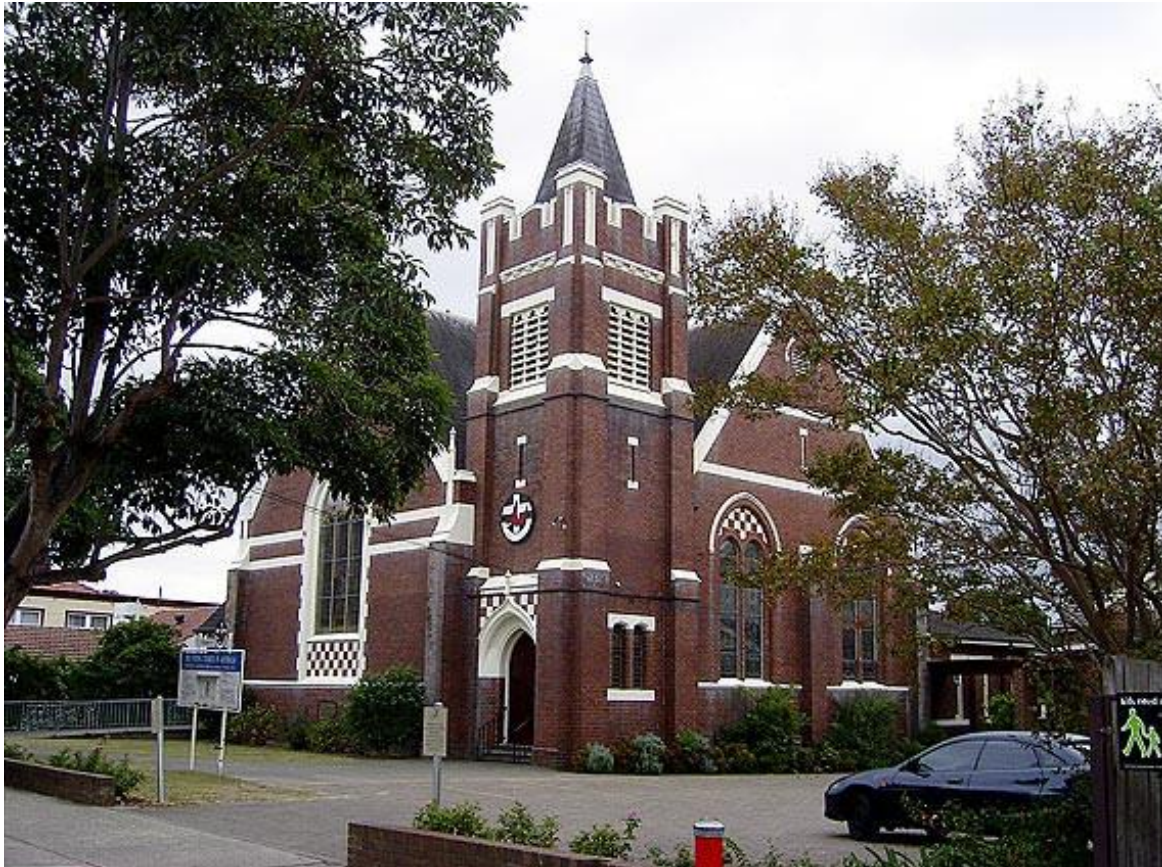
Figure 11: Strathfield Uniting Church.¹⁴

Uniting Church Strathfield, 13 Carrington Avenue, Strathfield – Designed by Alfred G Newman as a Methodist Church in 1907-08.¹² This is perhaps the most impressive of Newman's buildings, with strong repeated use of the same rendered bands and chequerboard pattern as seen at 389 Illawarra Road. Listed on the local heritage register for its aesthetic and historical value.¹³

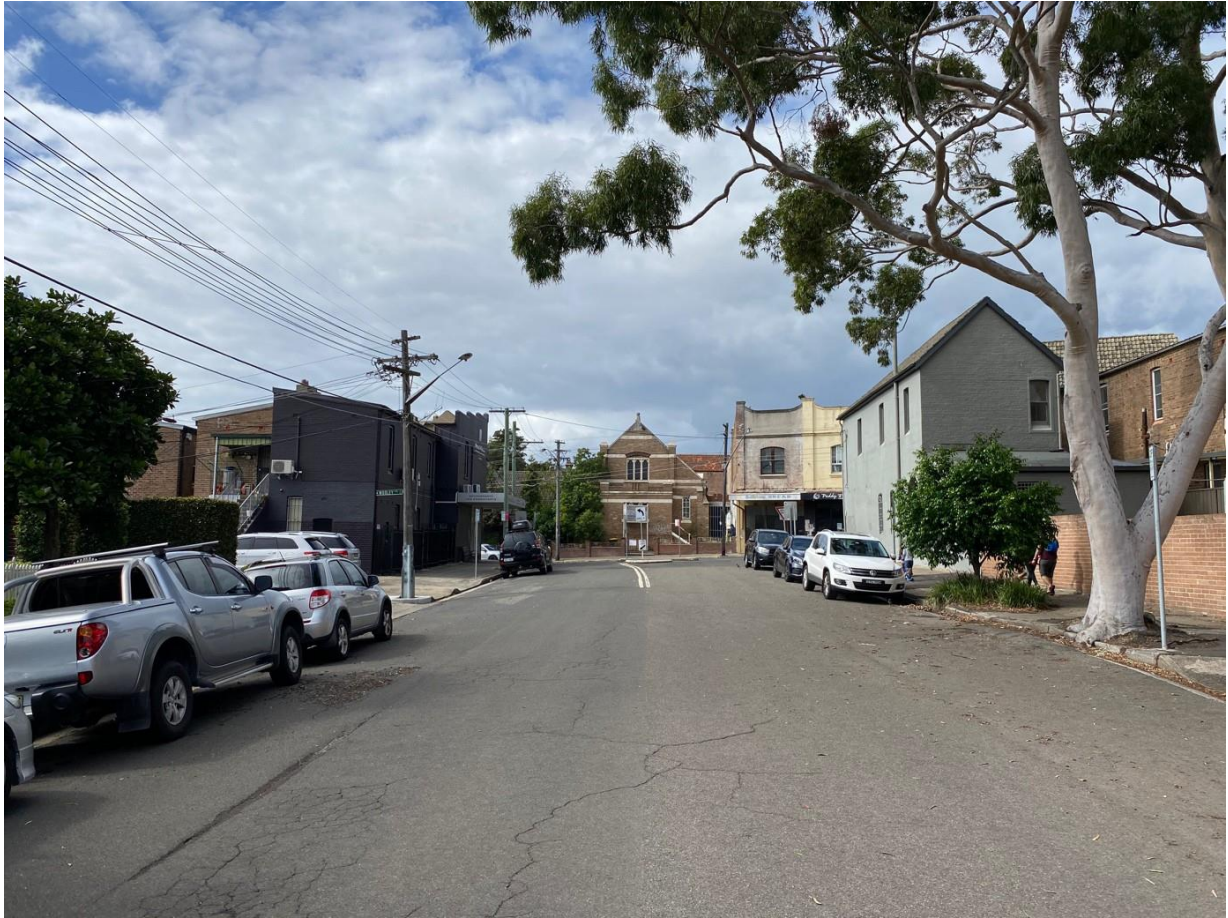
The above view of the church, looking east along Greenbank Street, shows it as a landmark. This is the most significant view of the church.

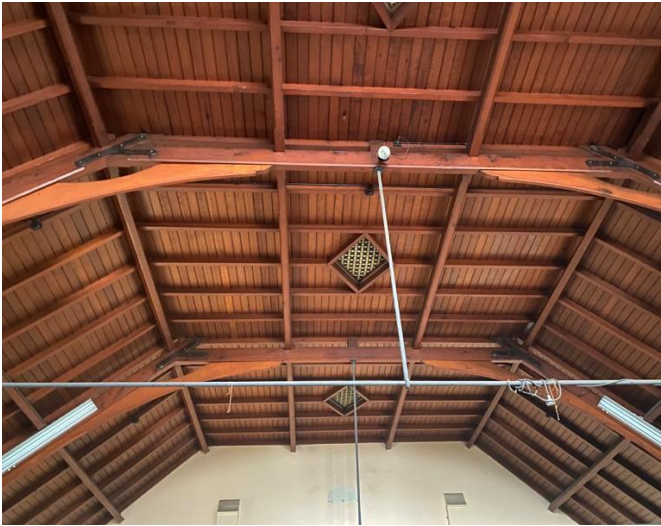
Element	Description	Date	Significance	Images
Interior				
Main chamber				
Ceiling lining	<p>Open frame timber truss purlins rafters lined with boards on the lower slope and the primary truss horizontal. All presented as clear finish.</p> <p>The lower bracing of the truss formed into a half Oval. The three trusses are supported on knee braces and rendered or stone corbels.</p> <p>Tie rods connect the small hammer beam horizontally and vertical to the main beam of the truss.</p> <p>The centre of each of the four ceiling bays are diamond shaped grills for ventilation in perforated metal</p>	Original	E

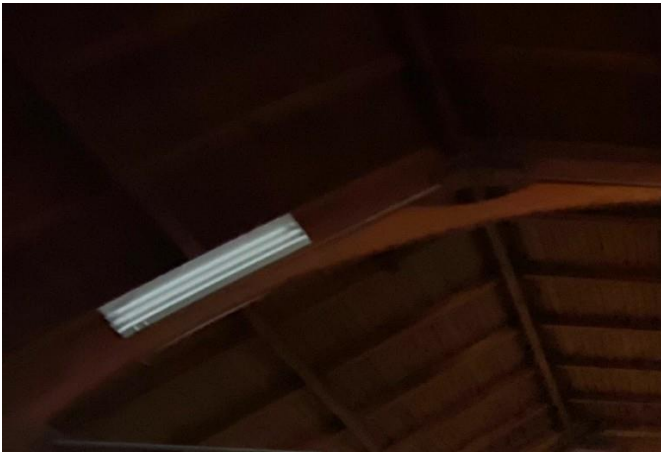
Lights	On the primary trusses are fluorescent light fittings mounted to the inclined member.	Late 20 th century	I

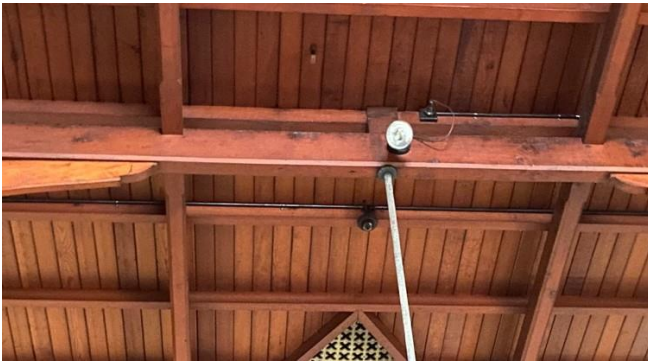
Floodlight mounted on the middle truss, Southern side and the top of that truss	Early 21 st century	I

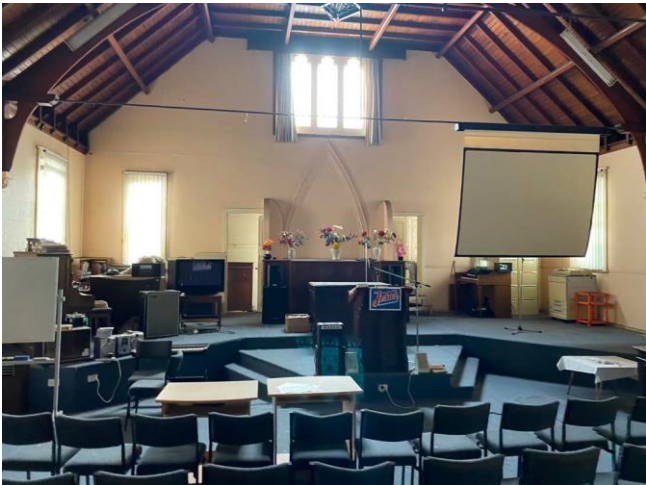
Walls	Rendered and set masonry, painted, with inscribed dado rail at the level of the windowsills, scribed out in ashlar coursing above the dado.	Original	E	
	At the west end niche formed by a pointed arch and infilled	Architrave and niche original Infilling 1940	E L

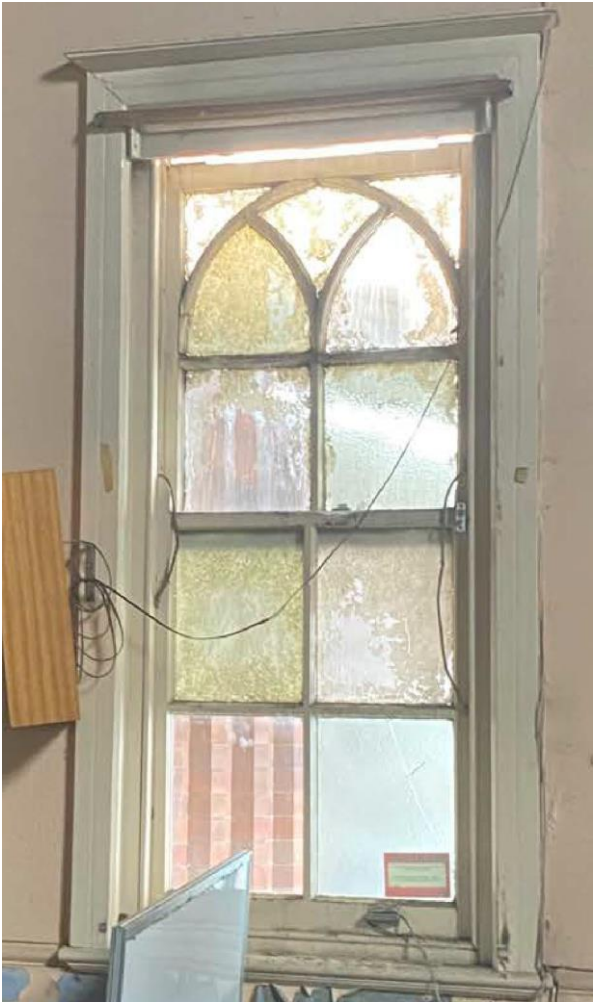
Windows	<p>North and south wall (7) West wall (2)timber box frame double hung windows. The lower sashes divided in four with horns, the upper sash is divided into a Gothic tracery. Beaded and chamfered architrave bullnose sill board with overload bed mould, deeply chamfered headboard</p>	Original	E

<p>West wall central – three light trace read window with plate tracery in the form of three lancets. Each has three sheets of fixed coloured leaded glass in a simple floral pattern</p>	Original	E

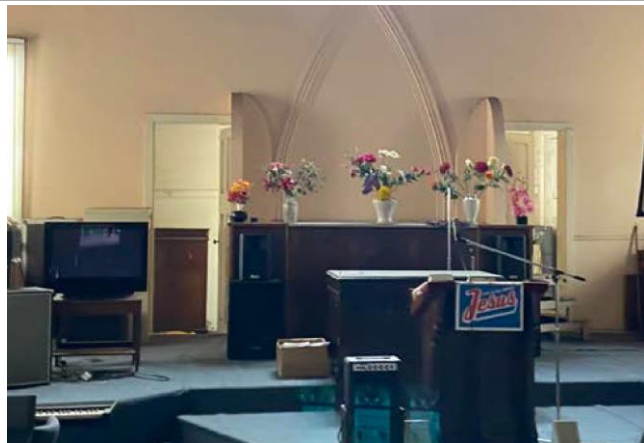
Doors	<p>West wall (2) solid timber rebated jamb lining, beaded and chamfered architraves, four panelled leaf on cast-iron hinges with decorative knobs, the leaf is three panels and very high waisted.</p> <p>On the vestry side the lower panel is boarded vertically with jointed boards, the upper two panels are devised with sunk moulds. On the main chamber side the doors are four panelled with stop chamfered details boarding to the lower and solid to the upper panels. Each door leaf has a mortise lock and Florentine brass decorative knob set with large backplate. Yale night latch.</p>	Original	E

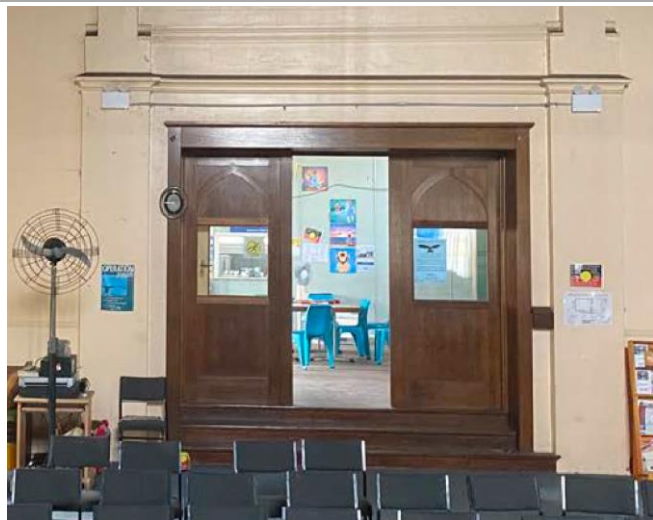
Door east end	<p>Polished timber solid timber jambs flush architraves with moulded headboard. A set of three steps in the thickness of the wall. Three semi glazed leaves. The middle leaf swings as a door leaf. Each leaf is two-panelled with an arch in the frieze panel. Polished Maple.</p> <p>The glazed panels have been inserted and trimmed in Pacific Maple more recently. The centre panel has a mortise lock and late 20th century brass lever set. The two side panels are removable they are held in place by four straight bolts of the 1930s in character.</p>	1940 with modifications from the late 20th c	H

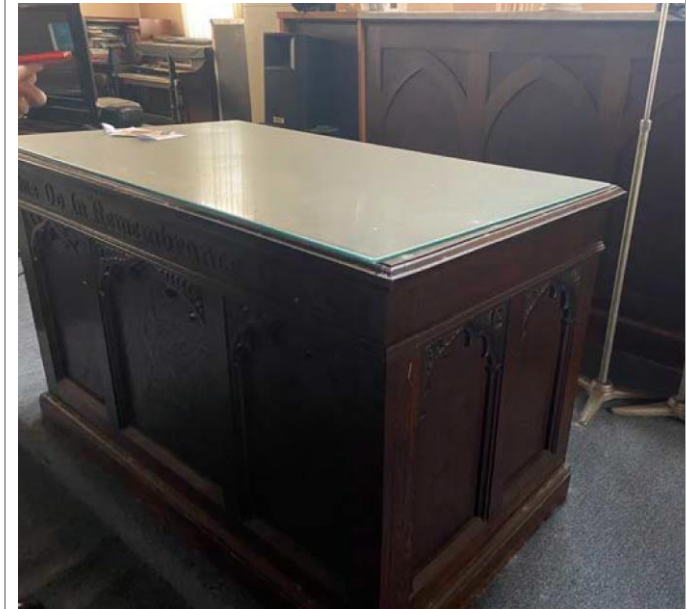
Reading desk	Located on the forward platform is a Polished Australian cedar reading desk in the Victorian Gothic revival style. The shelf has been augmented by a velvet covered mounted top.	Mid to late 19 century with 1930s top	H

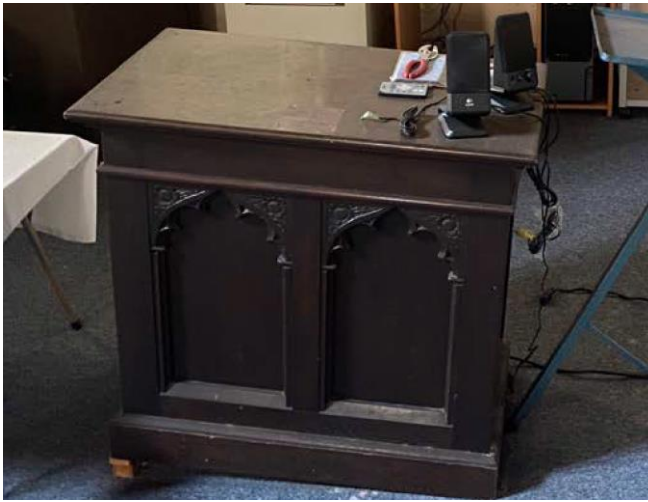
Side table	<p>Currently placed on the raking floor a small side table oak, with panels very similar but not identical to the communion table. Evidence of a glass top now missing. A brass plaque reads:</p> <p>“In loving memory of / Hazel May Linford/Died 27 August 1944. / Albert Henry Linford./ Died 17th November, 1954. / Albert John Linford (RAAF)Died 4 January 1945. / Victory in death.”</p>	1930s or 40s	H

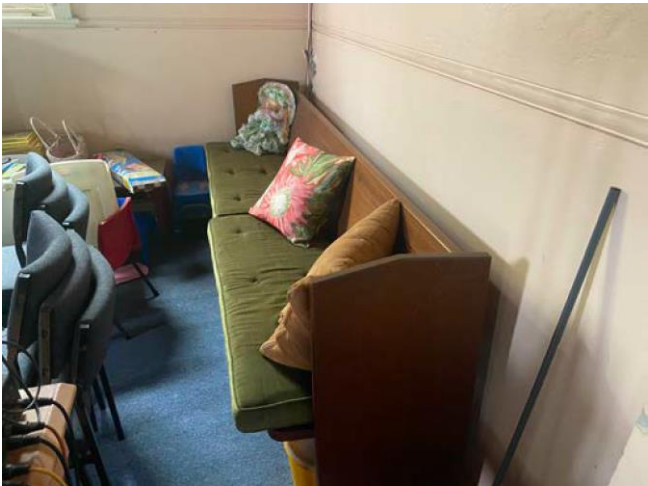
Pew	Queensland or Pacific Maple, Loose but and located against the east wall.		M

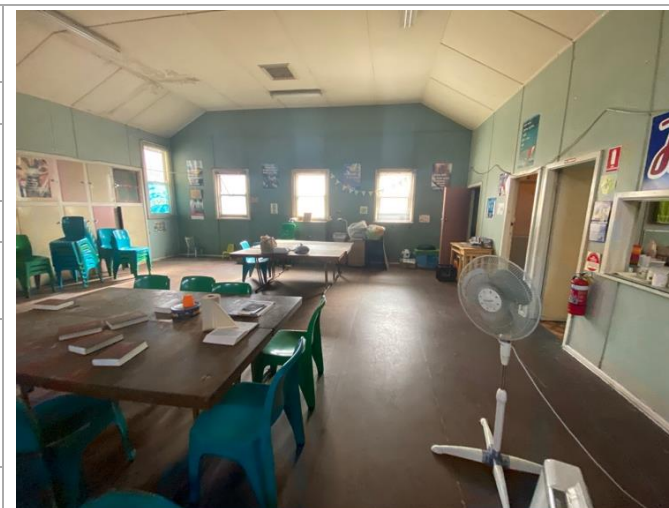
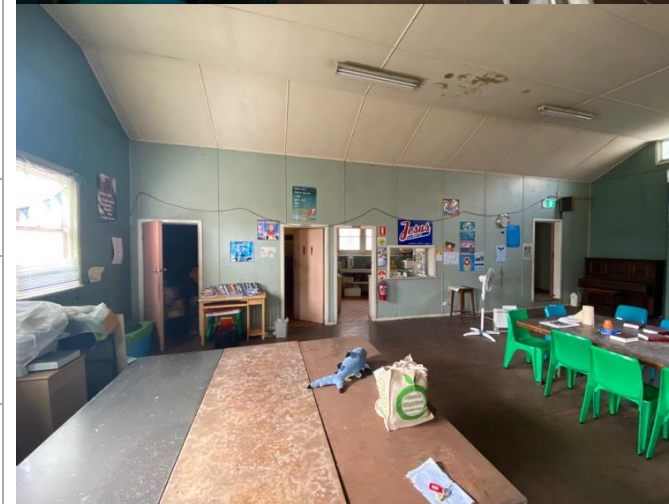
Windows	Three in north wall one in the west wall Timber box frame double hung. Bullnose architraves bullnose still bored quad bad mould. Separate glass timber and aluminium venetian blinds	1950s the Venetian blinds on one of the windows is the 1950s but on three of them	L

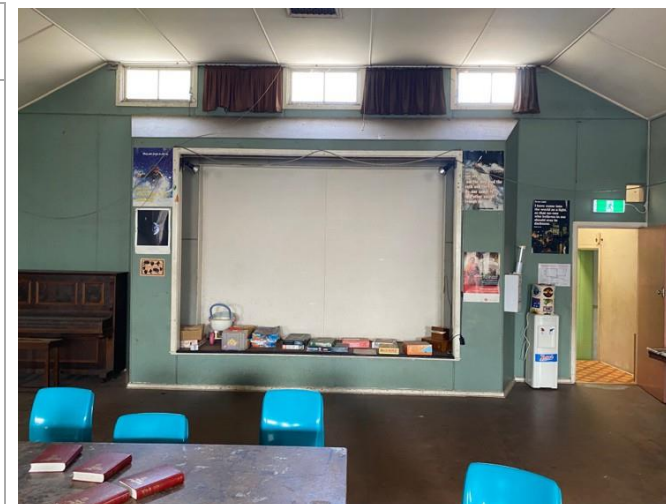
would be late 20th century		
Windows	South wall above stage. Solid frame three Awning hung sashes. Square architrave Rope and chrome painted opening mechanism Curtain on continuous aluminium track across all three	The curtain 1950s The curtain and track maybe late 20th century There is a pulley system so that all indicating all three windows were open with the one were integrated into one system.	L	
Store room, kitchen, lavatories, rear vestibule, backstage,				
Ceiling generally	Hardboard with timber semicircular cover battens	1950s	L	
Walls generally	Hardboard with timber semicircular cover battens. External walls are rendered masonry	1950s	L	
Lights generally	Ceiling mounted plastic batten holder on timber mounting block	1950s	L	
Floors generally	Timber framed cypress pine flooring 90 mm	1950s	L	
Fitments	The storeroom has and coat hook board fitted mirror, decorative light fitting In the lavatories fitted cupboards matching the style of those in the whole cast iron enamelled basins, chromed coat hooks, porcelain lavatory sets, Moravian tiles, fitted mirrors		L

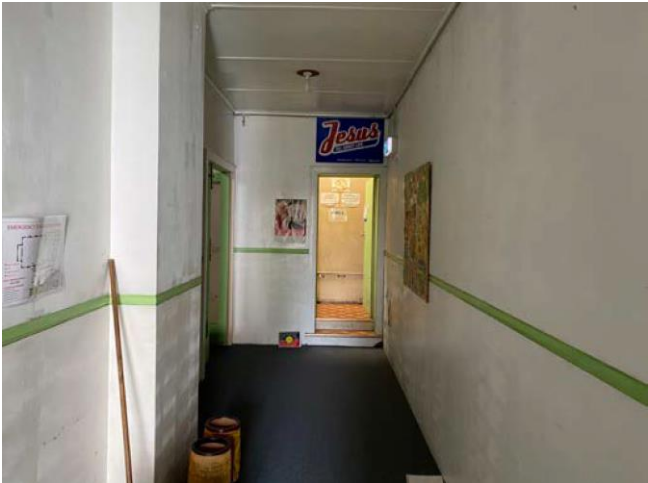
<p>In the kitchen fitted cupboards and stainless-steel sink detail rails laminate splashback, fitted shelf unit, fitted server unit with passthrough with sliding door, medicine cabinet</p> <p>In the back passage linoleum on the floor</p> <p>In the backstage a two large doors hung onto sliding mechanism to open into the stage</p> <p>In the external doors to outside threshold</p> <p>Double hung windows as for the whole</p>			
Plaque	<p>There is a plaque on the door to the backstage area:</p> <p>"This room is dedicated to the memory of / Gladys Pope / for many years beloved leader / of the youth of this church"</p>		M	
Side entry				
Ceiling	Hardboard with square timber battens and 50 mm overflow corners	1940	M

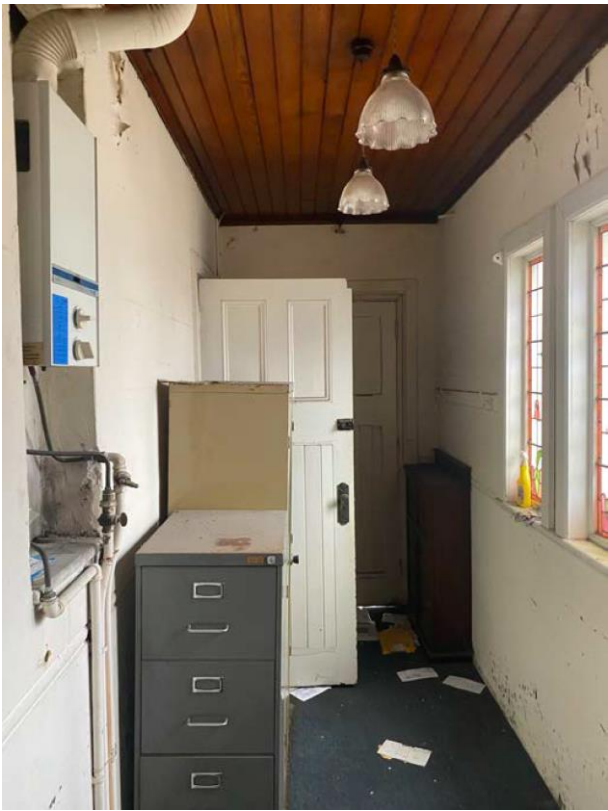
which are late 20th century		
Fitted desk top	Adjacent to the front door a small timber inclined to top nicely detailed suspended off the wall clear finish	1940	M	
Hall at West End				
Ceiling	100 mm the jointed timber with 50 mm Scotia Cornice	Original	H

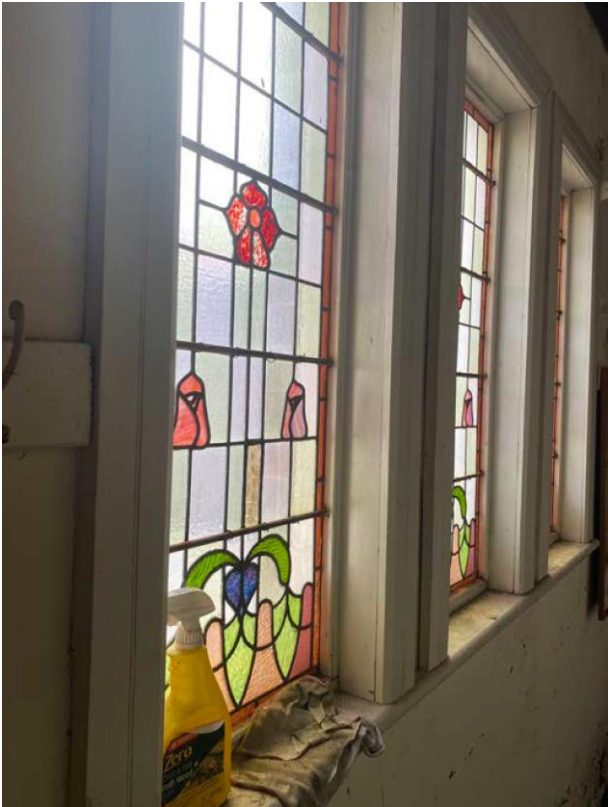
Windows	In West wall three solid timber frame timber elbow lining chamfered and beaded timber architraves fixed coloured letter glass	Original	E

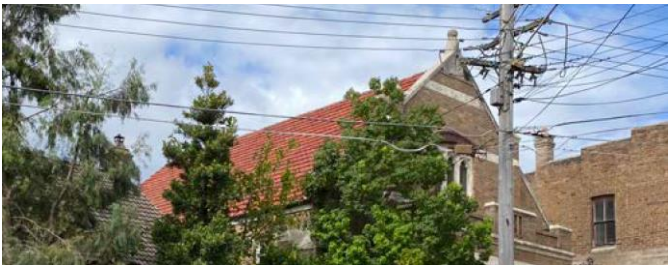
Exterior				
Roof	Glazed terracotta tile Marseille pattern main building on the hall colour bond	Mid and Late 20th century	M

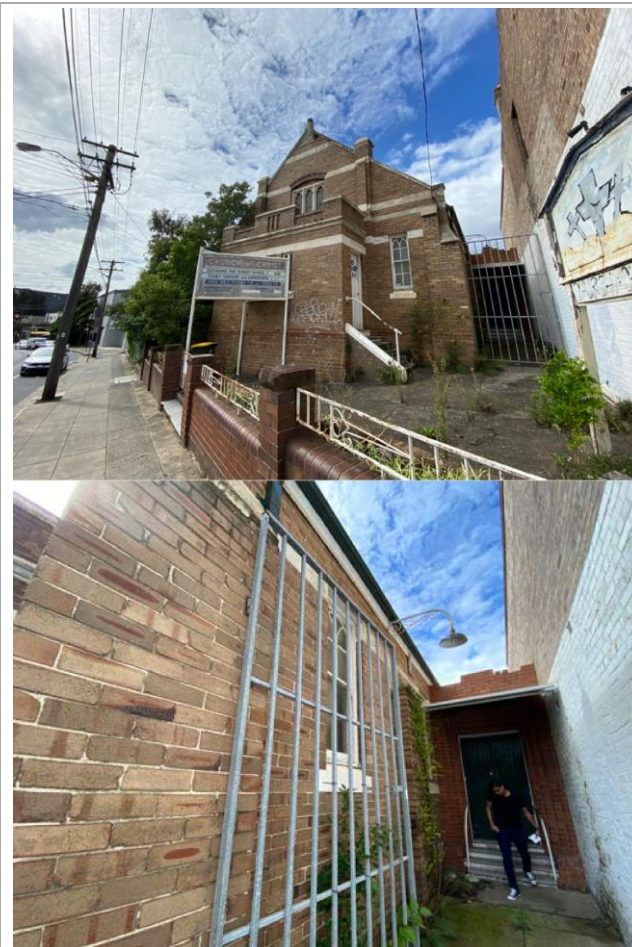
Eaves gutters	Quad pattern colour bond	Late 20th century	L
Eaves fascia	Timber 31 x 200 approximately beaded	Original	E
Parapet	Face common brick with rendered cement moulded coping. The coping to the buttresses projects above the parapet and it's finished in moulded cement. The apex has a cement finial with a sphere on top.	Original	E
Walls	Face common brick stretcher bond as for cavity construction. Cement rendered bands at the level of the door height window head eaves parapet base and upper parapet. The apex of the parapet is decorated with a panel of chequerboard floral designs carried out in render	Original	E
Base	Face common solid brick in English bond with special moulded chamfered step in course	Original	E
Front steps	Brick wall, rendered To wall, pipe handrail shapes with special and fitments to the post and the wall, marble trades and rises,	Original	H
1940 entry porch	Face red brick with a Deco style stepped parapet to right side steps pipe handrail aluminium awning	1930s the awning maybe 1950s.	M

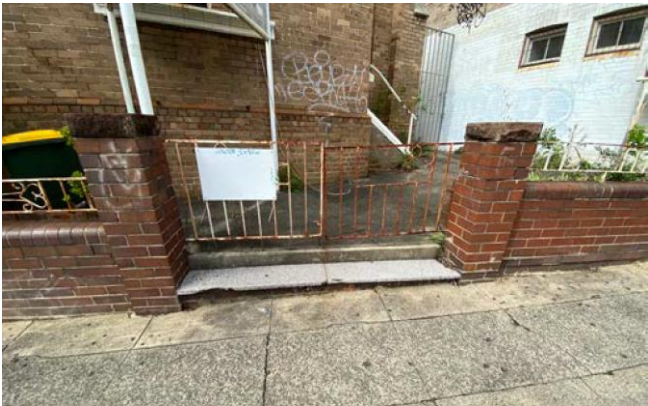
Front fence	<p>Solid face brick piers and inside wall with bullnose. The piers are capped in Sydney sandstone quarry faced. Above the brick wall is a wrought steel decorative panel. Behind the fence is a brick planter box.</p> <p>There is a terrazzo tread at the gates.</p>	The wall, tread and gates appear to be 1930s. The planter box, 1950s.	M

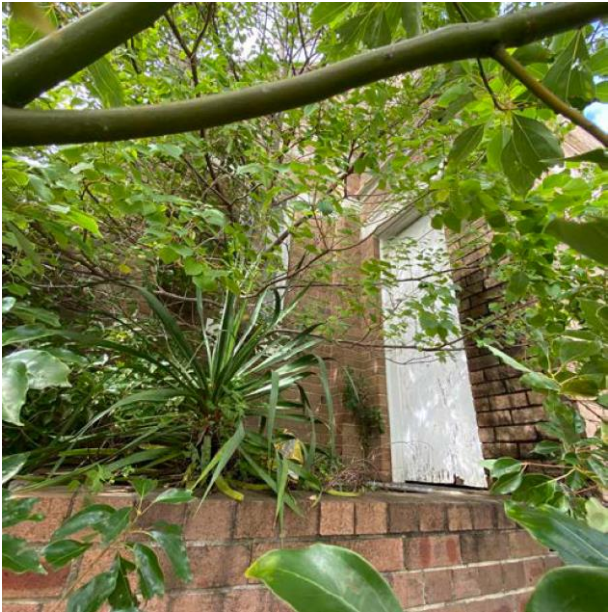
Other	To the former northern entry door the steps have been bricked up in common brickwork in the middle late 20th century		I
